SUBJECT: Technical Memo - Annaburg Manor

Follow-up Site Observations

Manassas, Virginia

Report dated: July 13, 2017

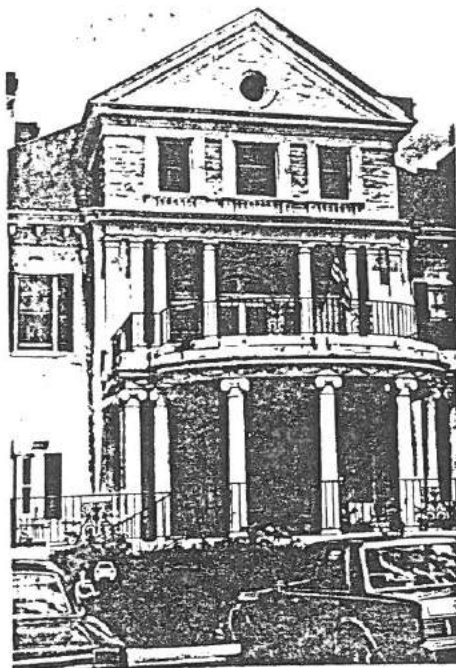
↑ Front porch, left side

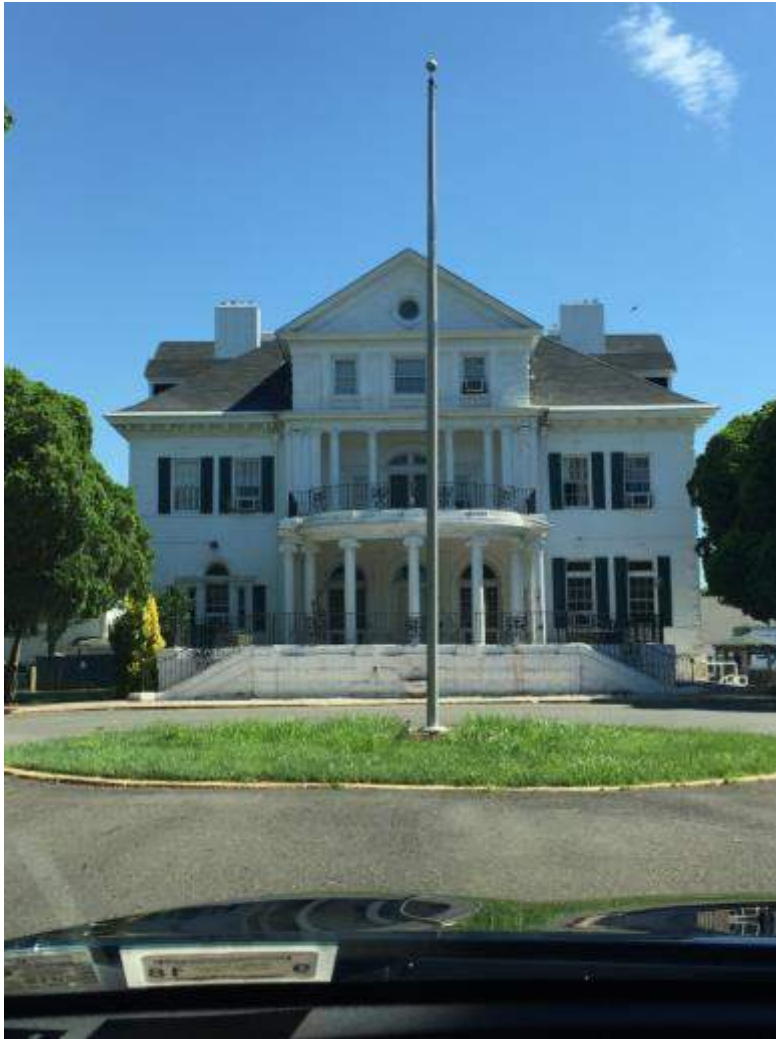
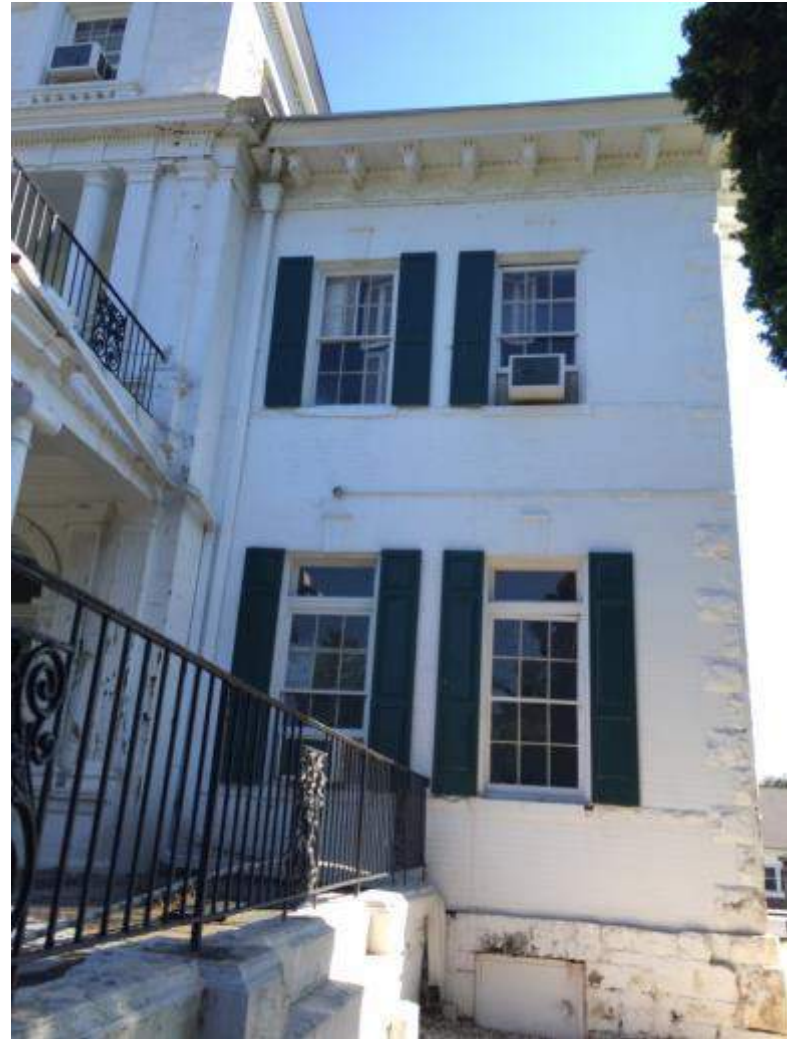
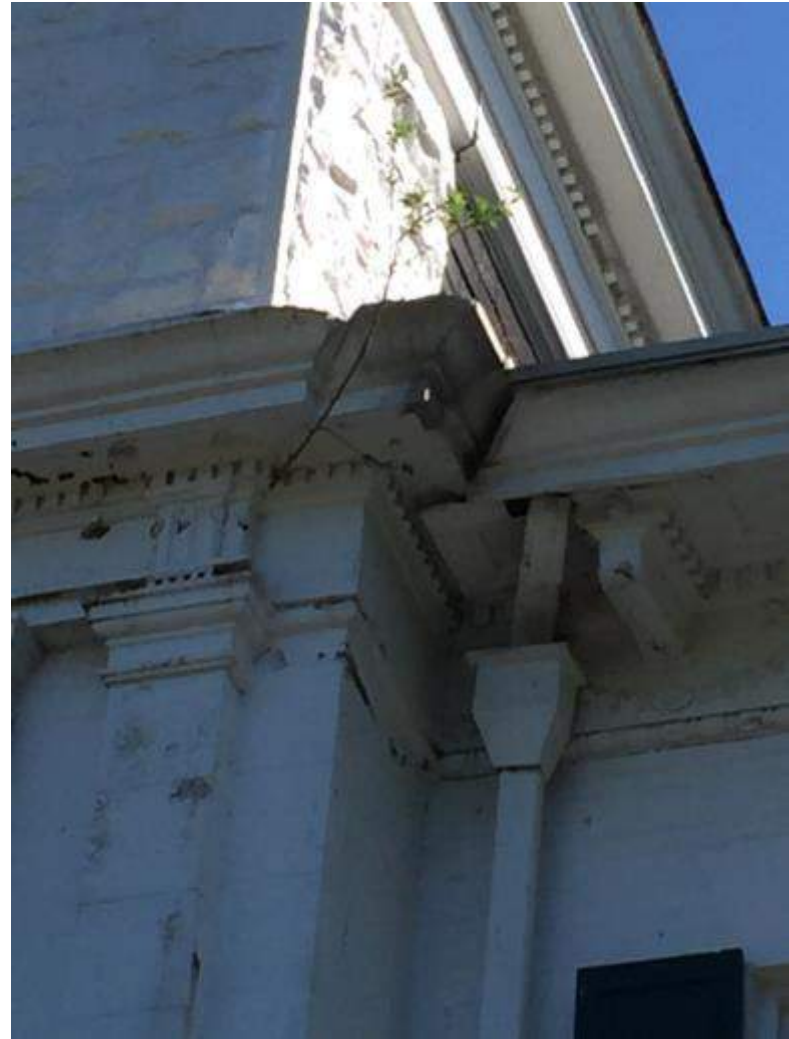
Photographs Numbered 1 through 4 identify the front elevation of the building. We were quite surprised to see the amount of deterioration on the cut stone portions of the façade as well as on the columns that support the terrace above. Photographs Numbered 5 through 12 show a closer view of some of this deterioration where it appears that water that is in the brownstone components is resulting in failure of the coatings, resulting in an extremely undesirable appearance of these areas.

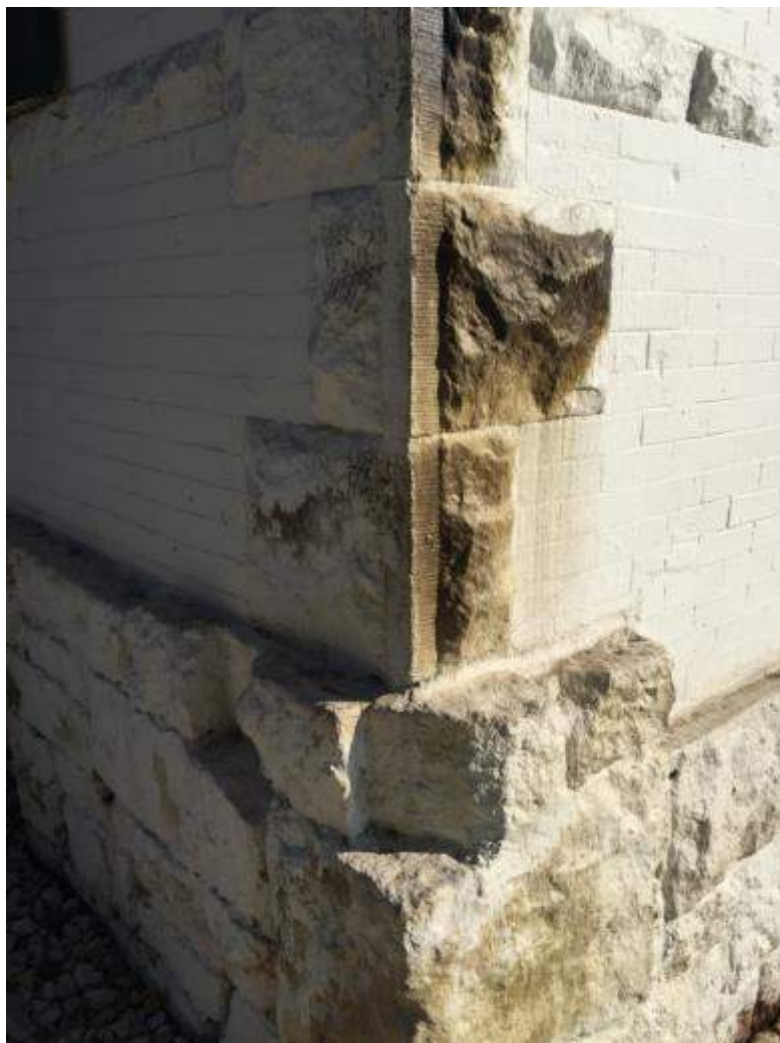
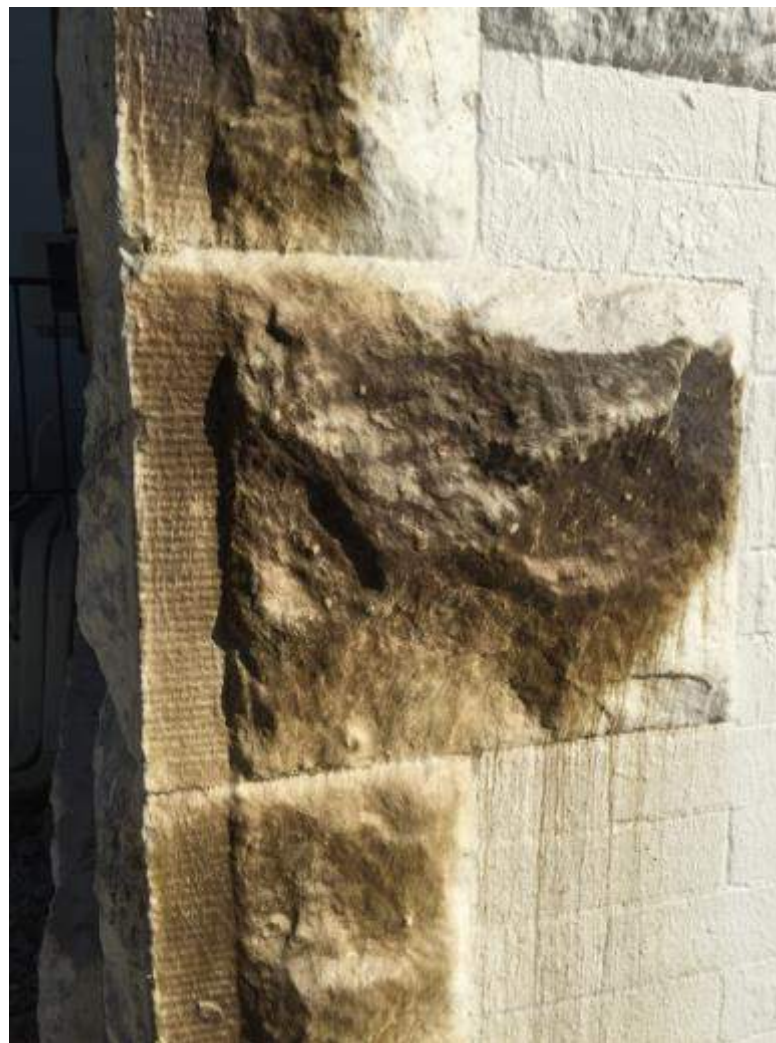
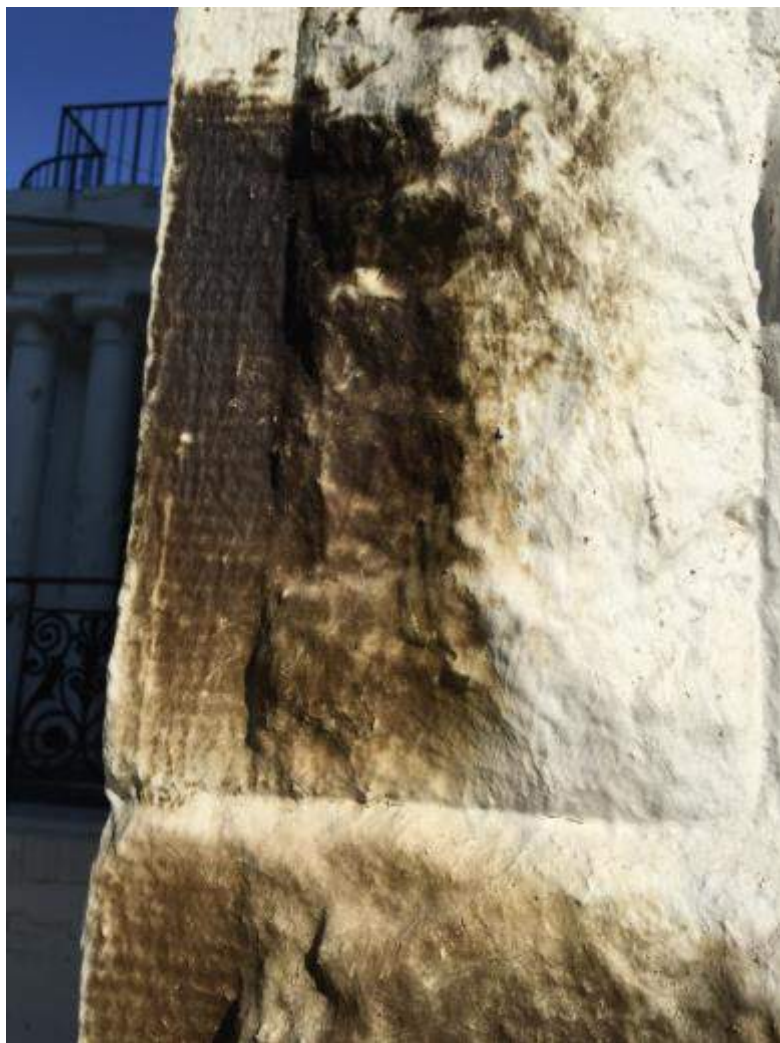
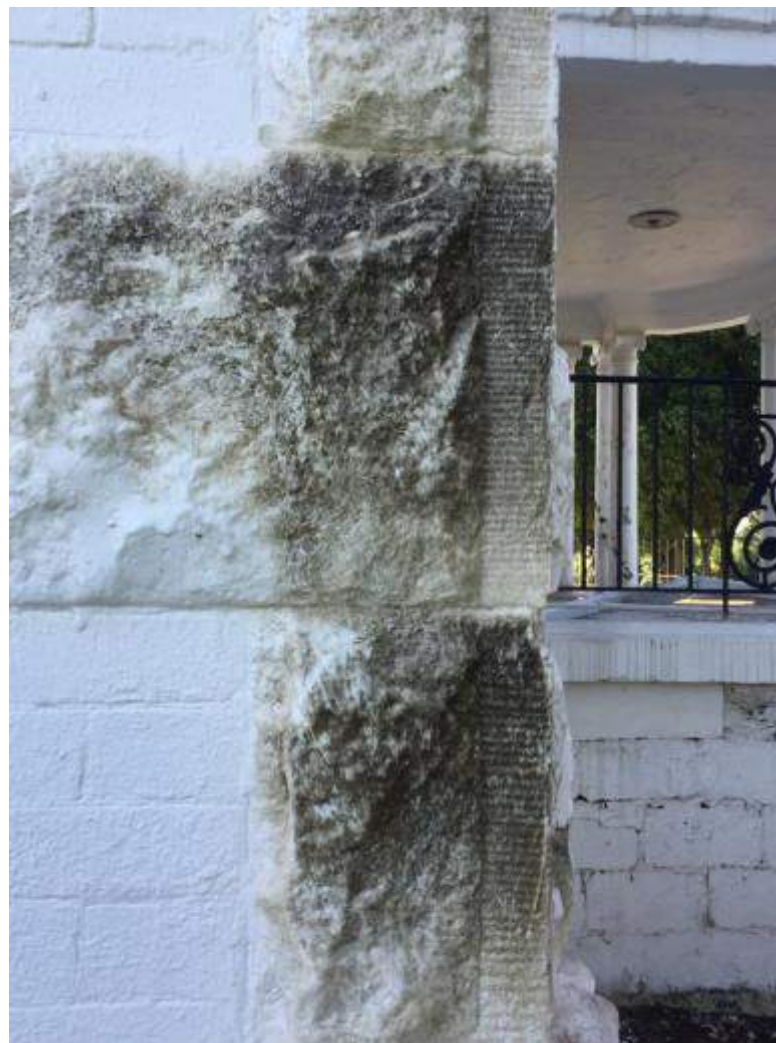
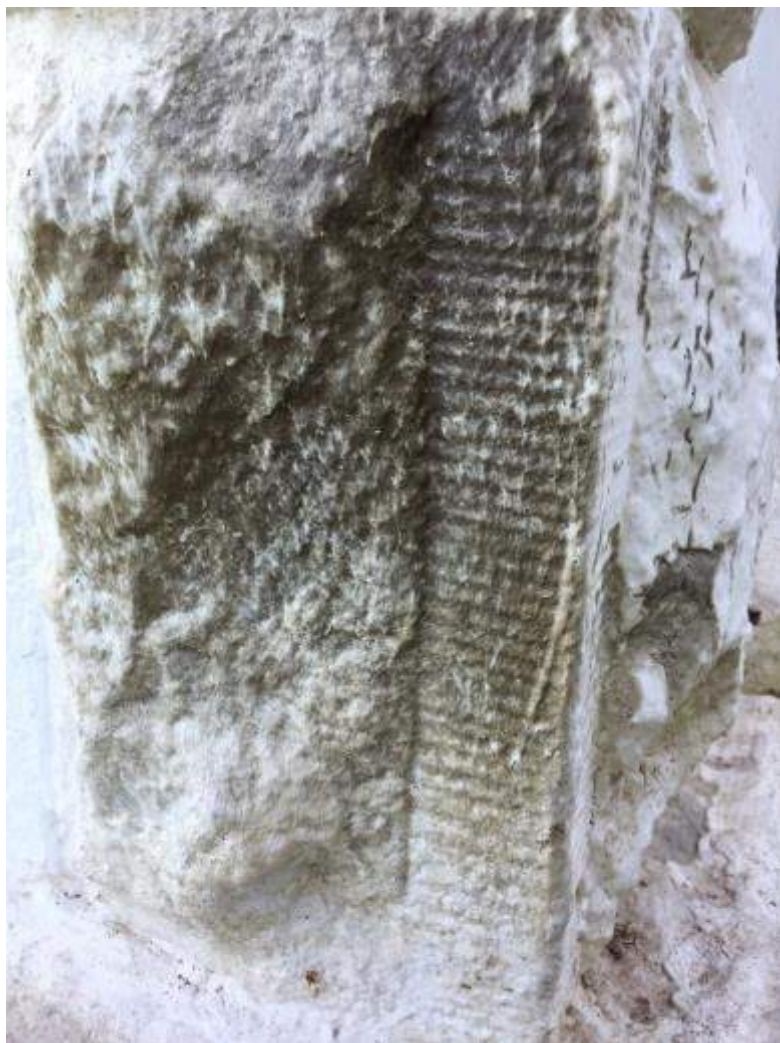
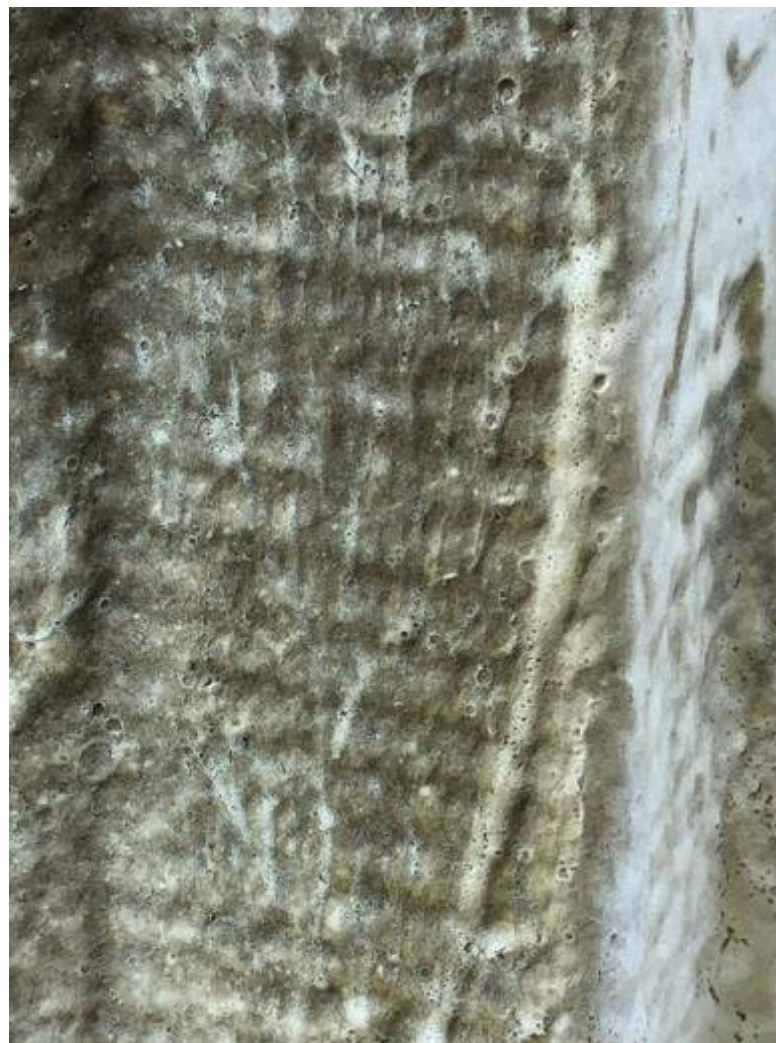
Photographs Numbered 13 through 18 identify the brownstone cornerstones in which some of them exhibited severe staining on the surface of the coating. The cause of this staining appears to be dirt pick up from water cascading down the corners as opposed to water that is behind the cornerstones. As seen in photographs later in the report, it does not appear that the coating has been compromised relative to its ability to protect brownstone in these areas.

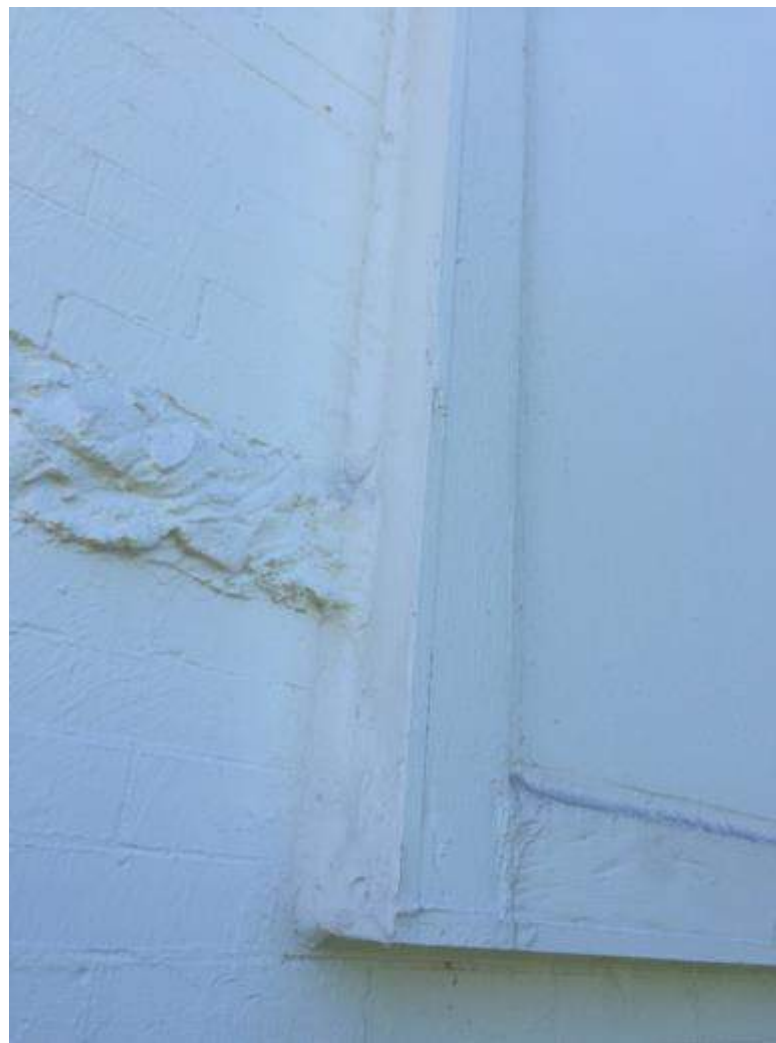
Photographs Numbered 19 through 26 identified the sides and rear of the building that largely appear to be in good shape with some minor exceptions. Photographs 25 and 26 of that group show infill panels that were installed where major leaking has previously occurred. Both the joinery and the coating appear to be good and functioning properly. There were a couple of areas as seen in Photographs 27 and 28 where the cornice at the roof level, as well as some of the brownstone eyebrows were exhibiting some deterioration. We were unable to access the areas to determine the cause.

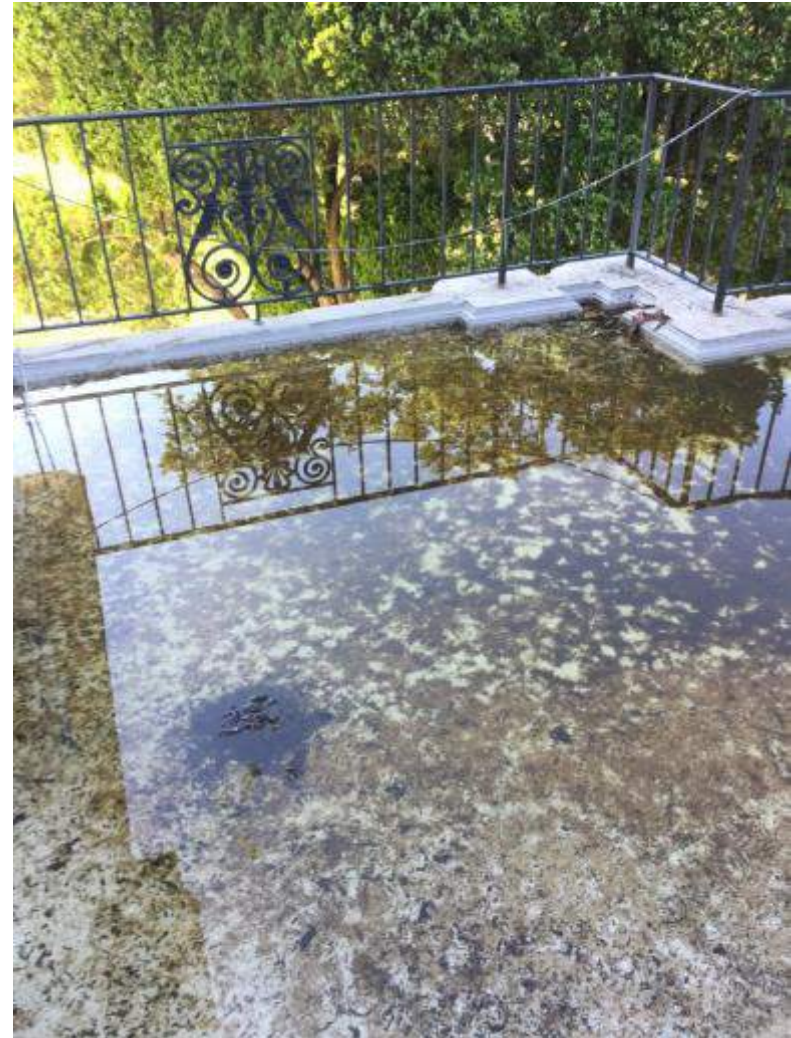
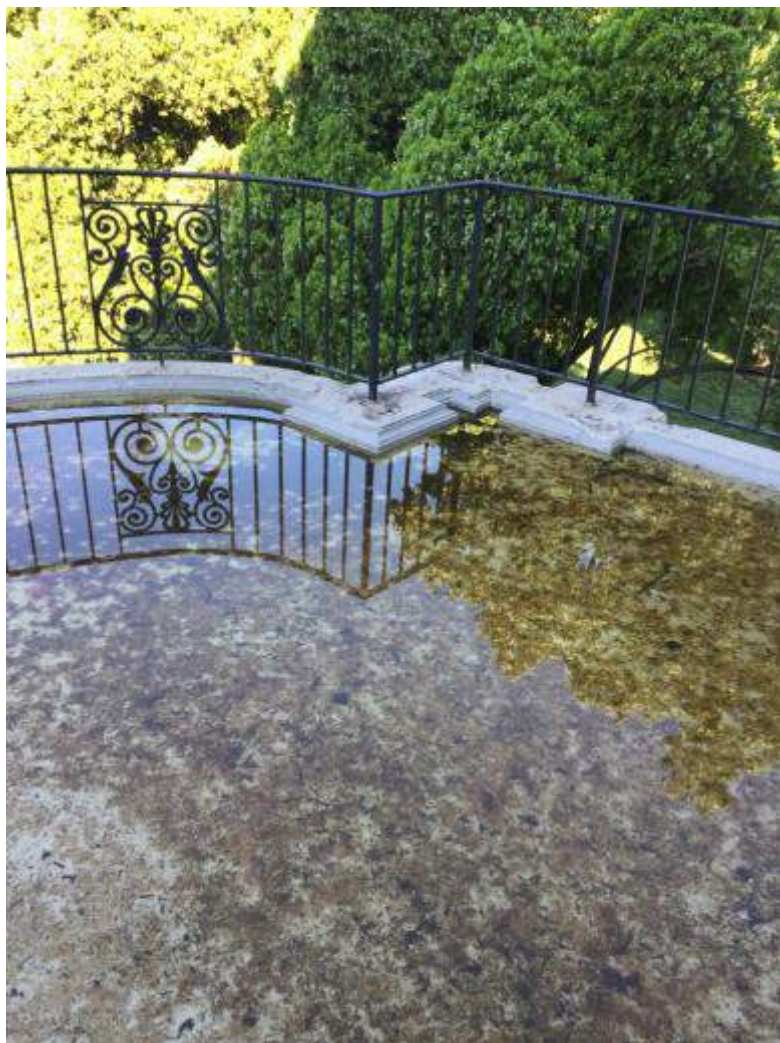
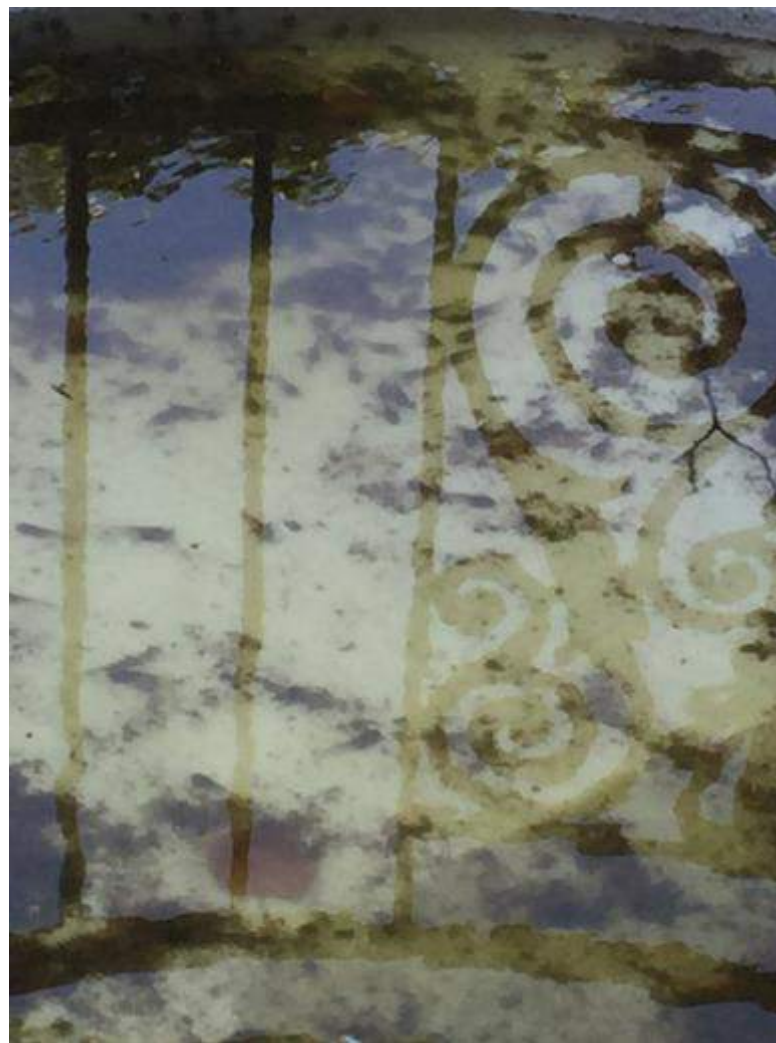
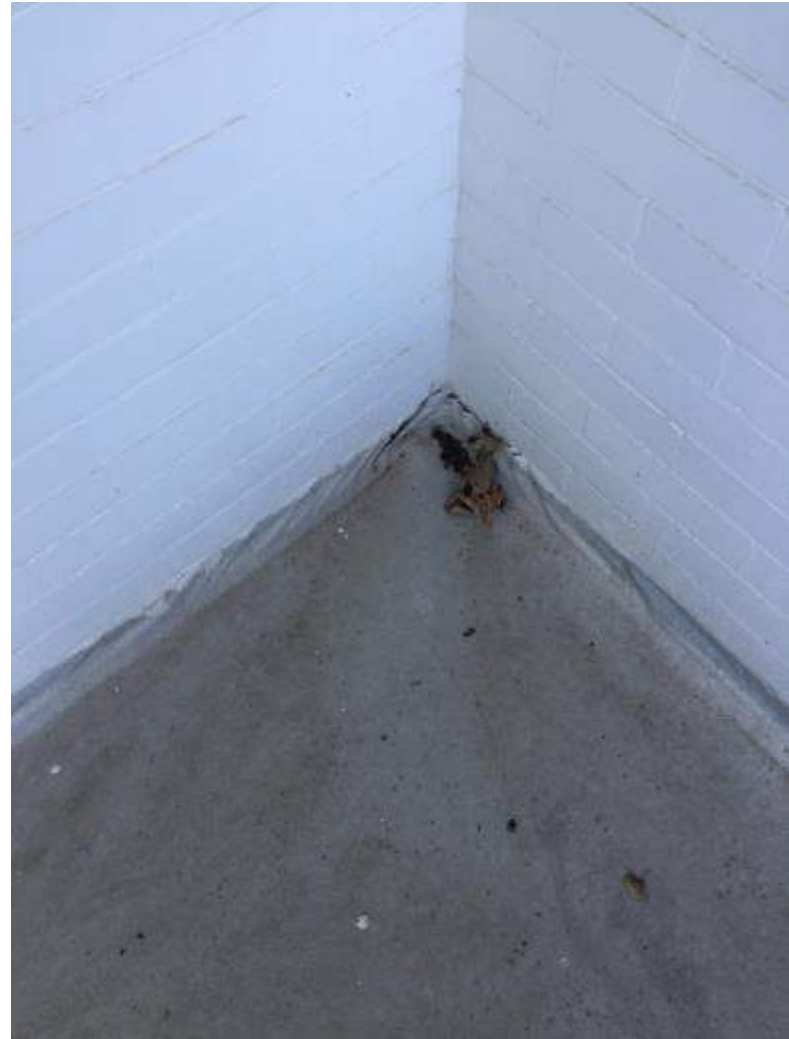
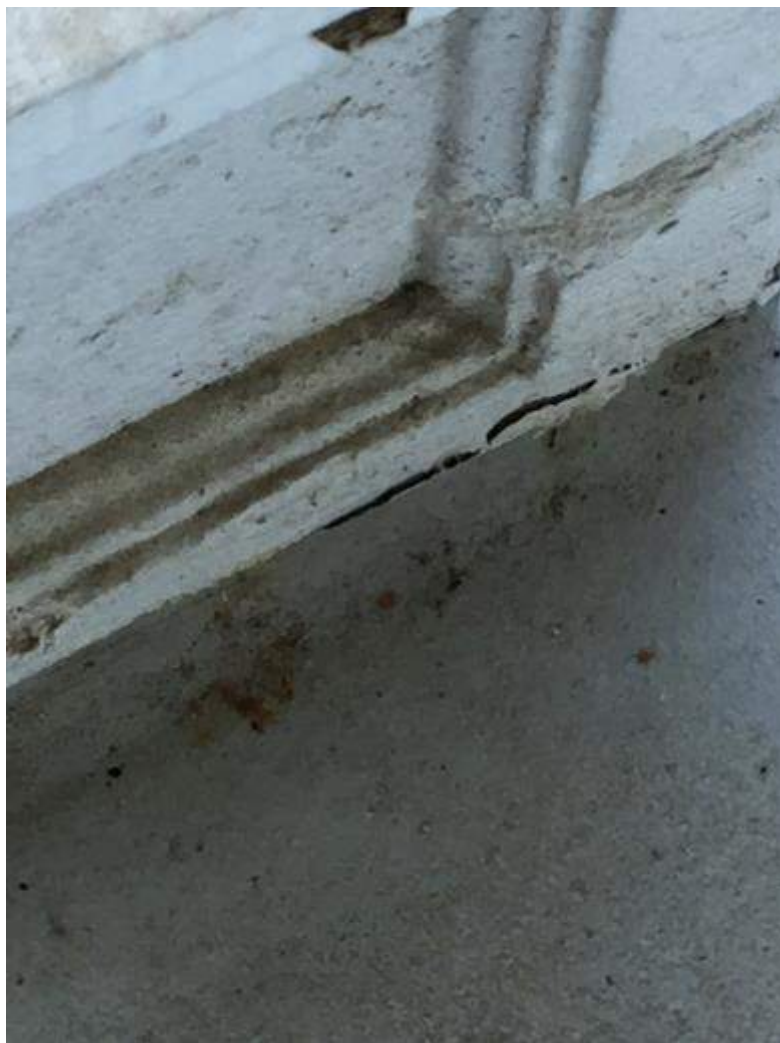
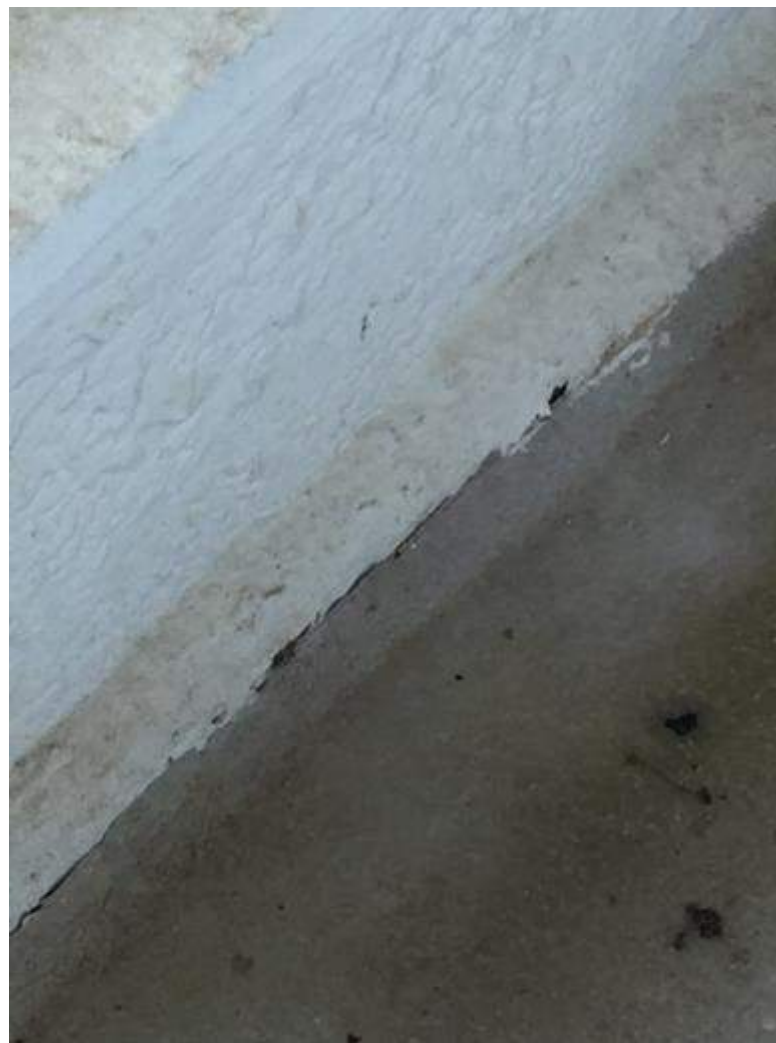
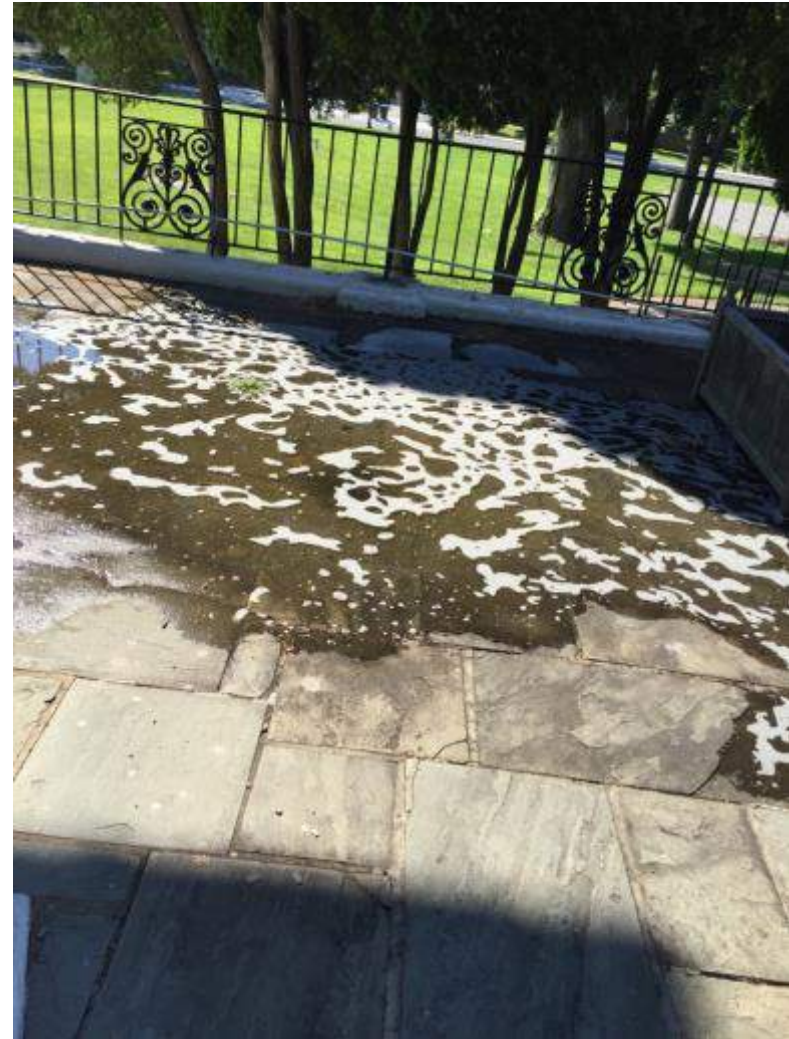
Photographs Numbered 29 through 38 are of the Terrace that is above the main entry on the front of the building. The drains in this area had become obstructed which was resulting in significant amounts of water ponding on top of the terrace for prolonged periods of time, to the extent that it was damaging the coating that had been installed on this terrace as well as the perimeter conditions where it ties into vertical surface. We believe that water is getting through the perimeter conditions of the terrace and migrating down into the brownstone below exacerbating the deterioration that is seen on the front of the building, primarily isolated to the area underneath the terrace. The water that is giving underneath the Terrace has also started deteriorating the plywood portion of the Terrace between the columns and the entry door that will need to be re-built prior to recoating. The plywood portion is the raised area seen in Photograph Number 33. Photographs Numbered 34 through 36 show the perimeter conditions where water has gotten behind the deck coating because the water has gotten deep enough to saturate these areas.

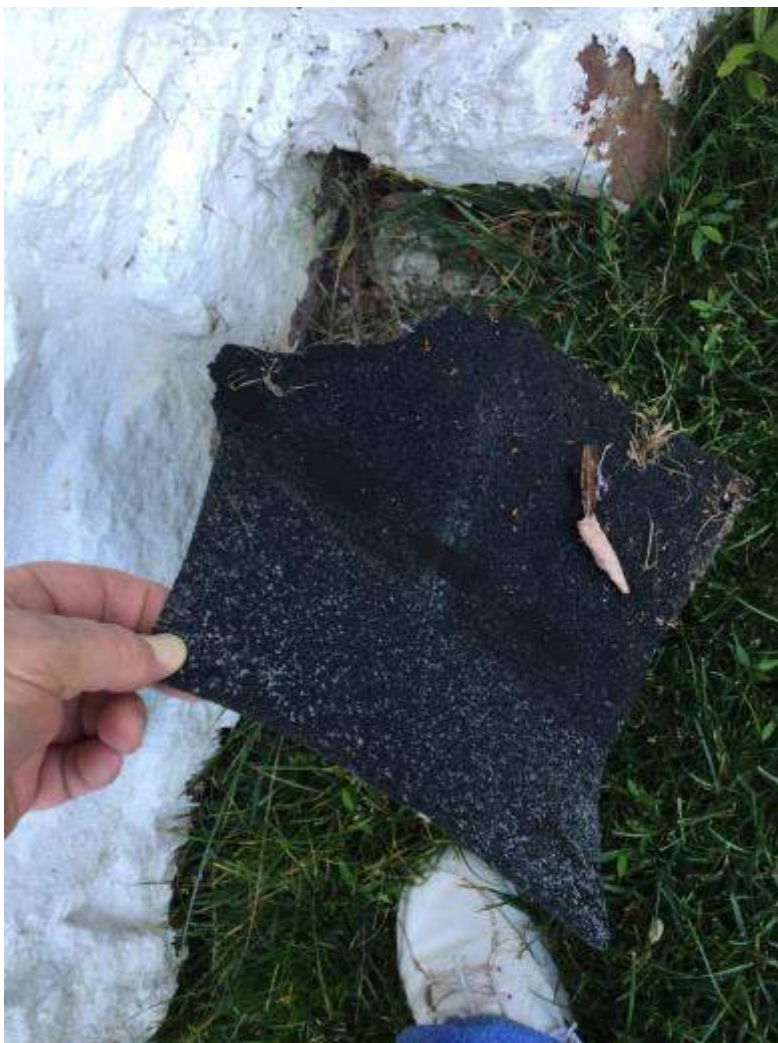
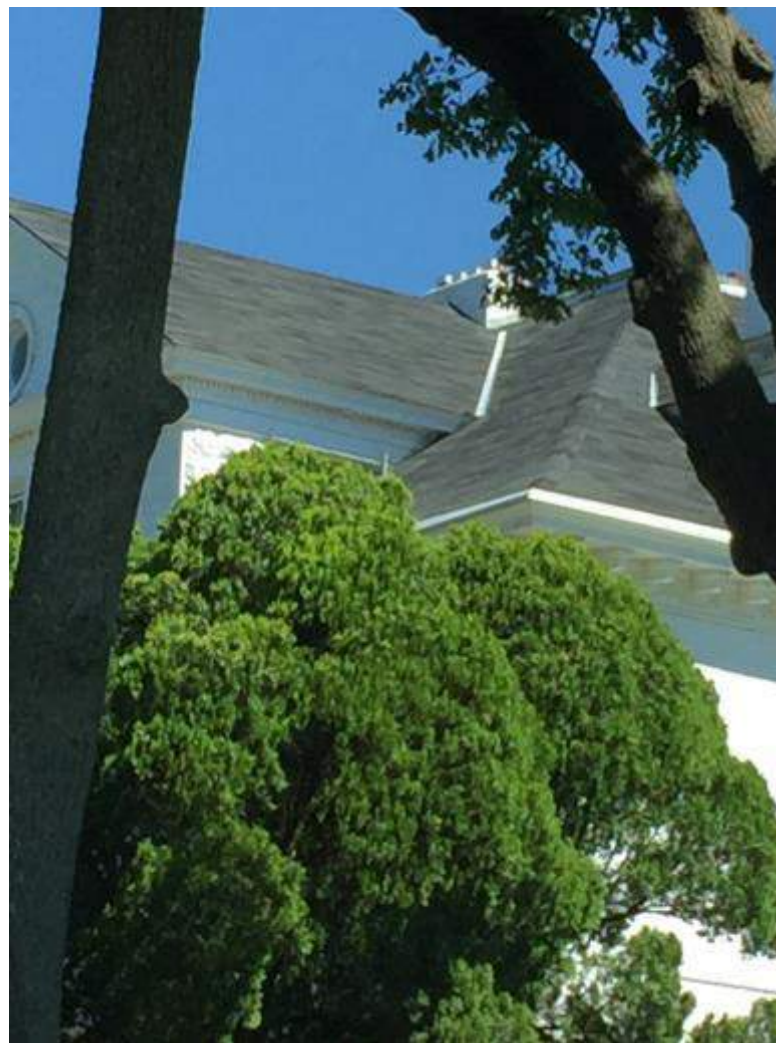
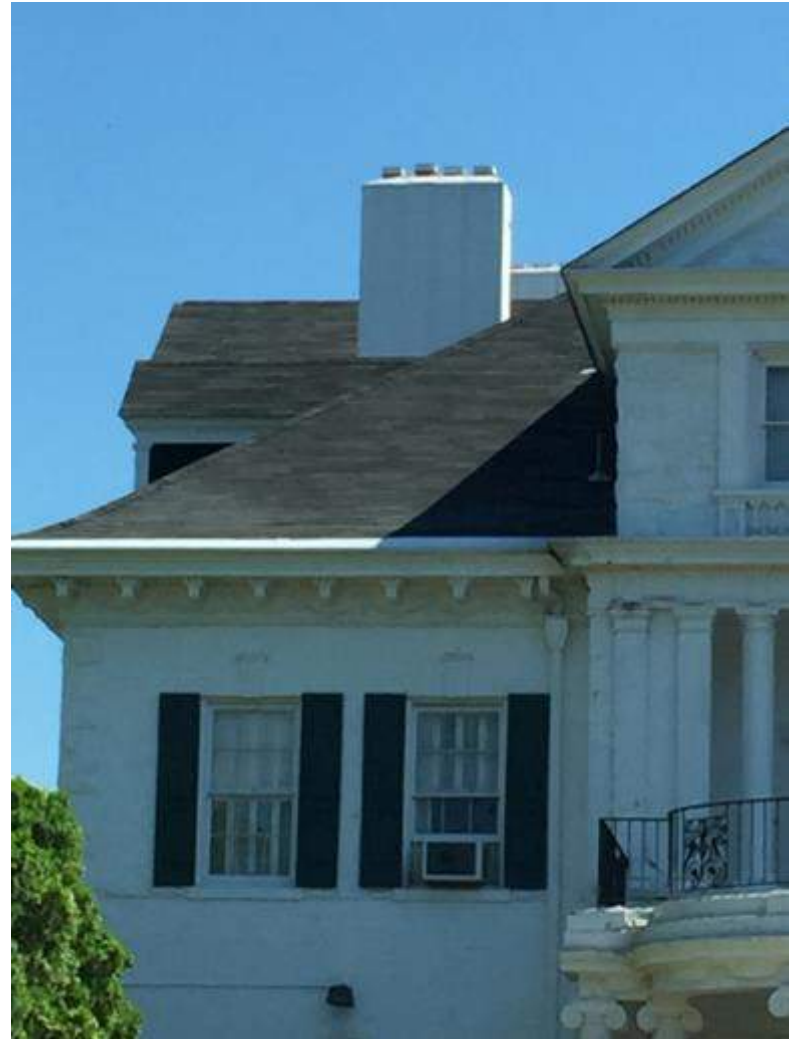
Photographs number 39 through 42 show the asphalt shingle roof that we were unable to access from a vantage point to determine any damage. The overall appearance did appear to be good from where we could see it, however we found several shingles on the ground that we do not know if came from the roof or from somewhere else.

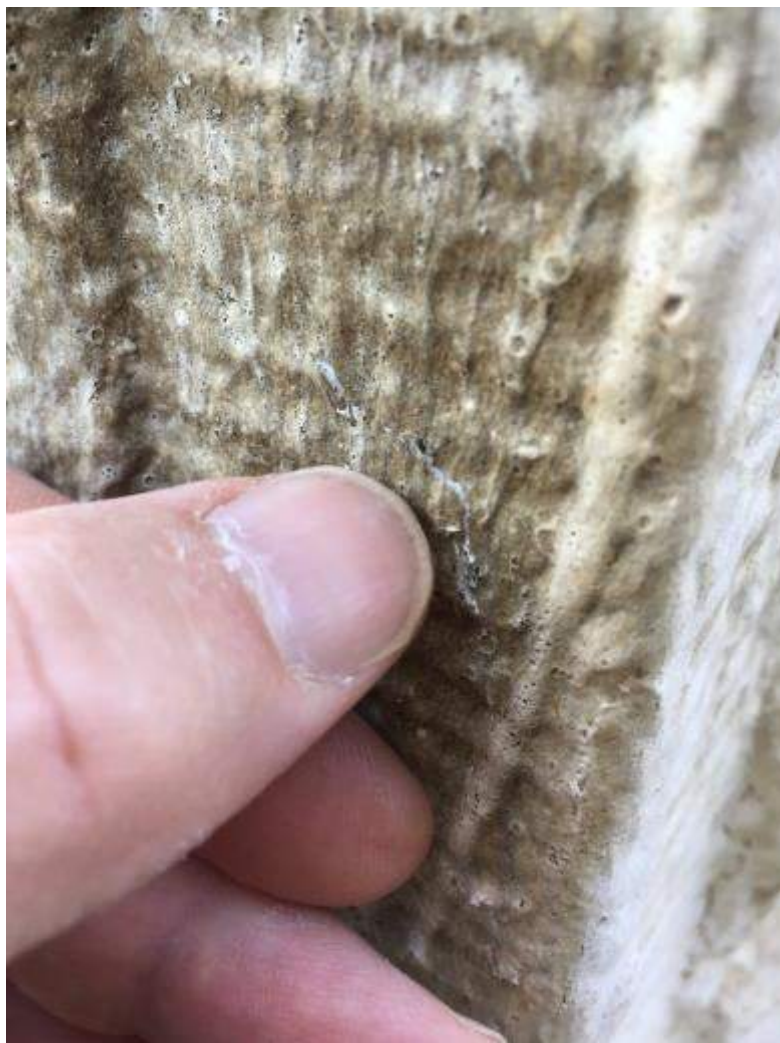
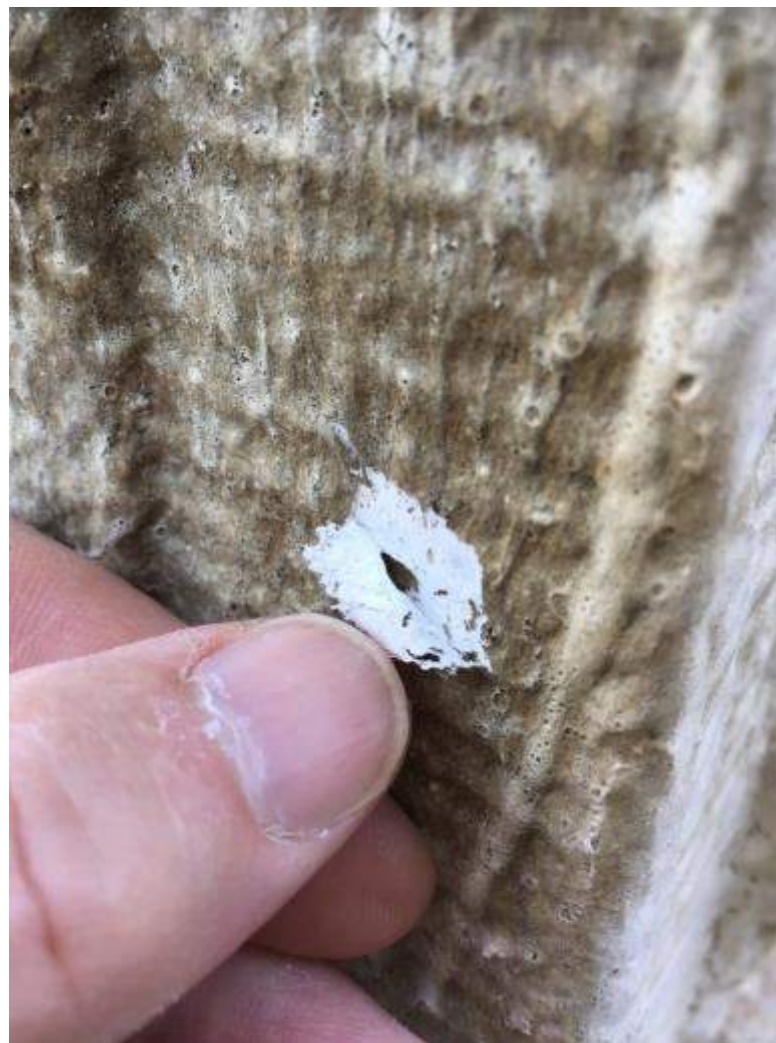
Photographs Numbered 45 and 46 shows staining on the brownstone cornerstones however where we sliced the coating at these locations, the underlying coating was still intact and bonded, and performing as intended.

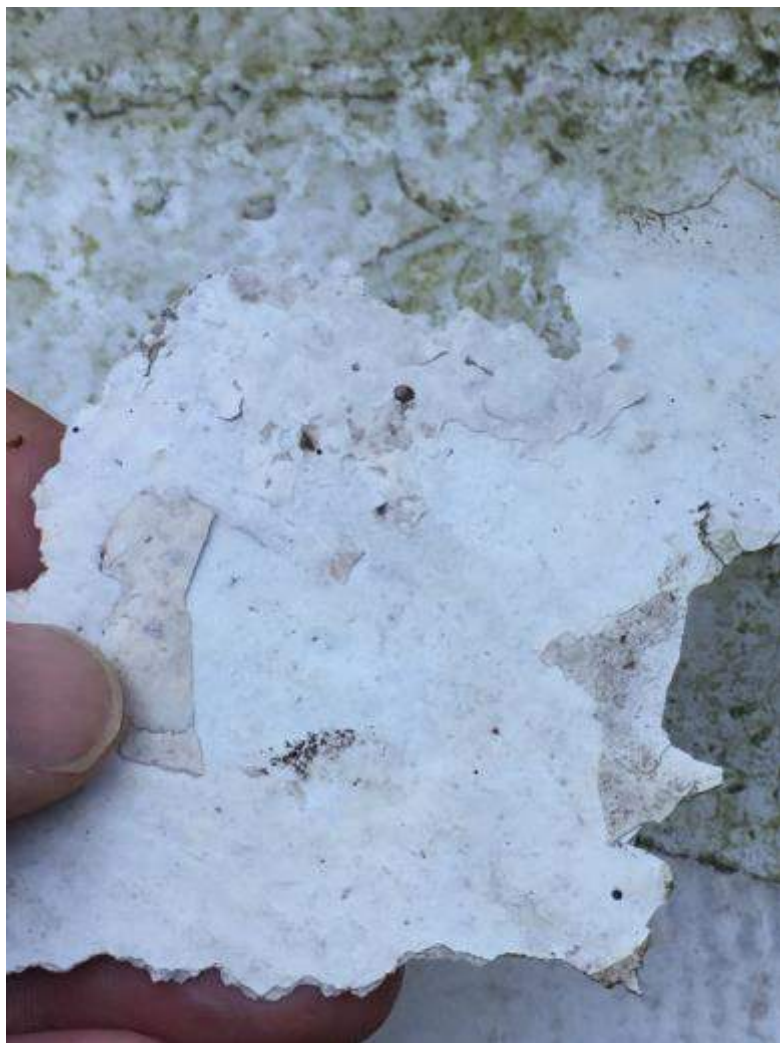
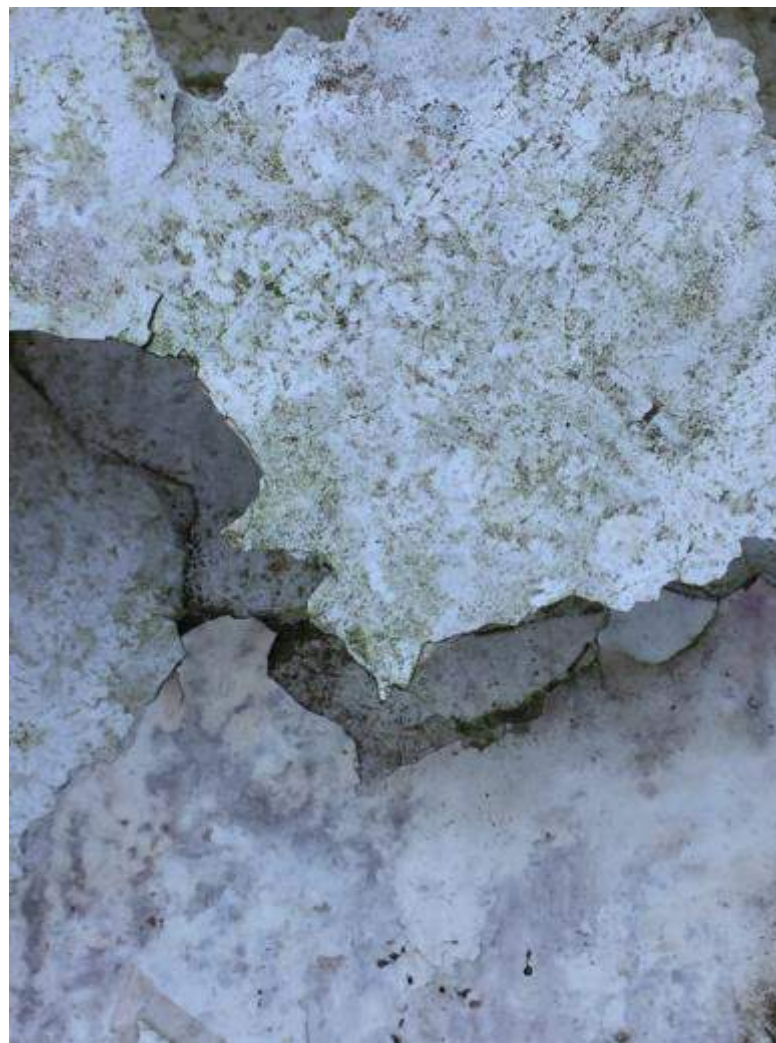
Photographs Numbered 47 and 48 identify where sections of the previously installed coating have delaminated from the substrate, due to moisture behind it.

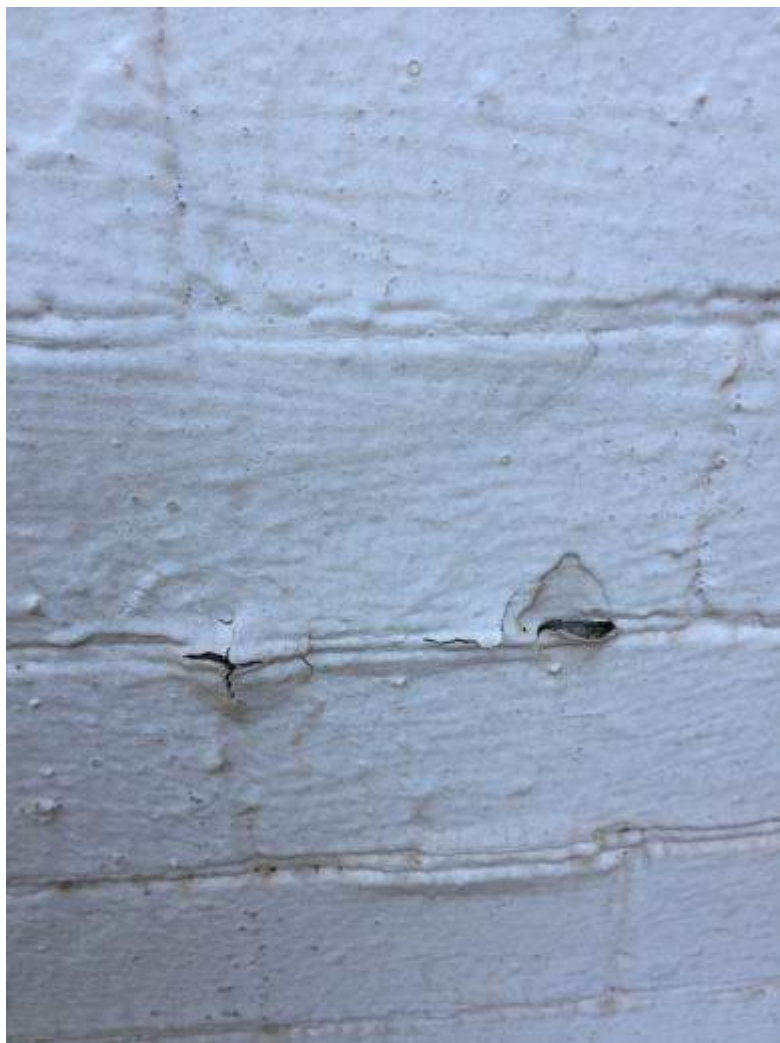
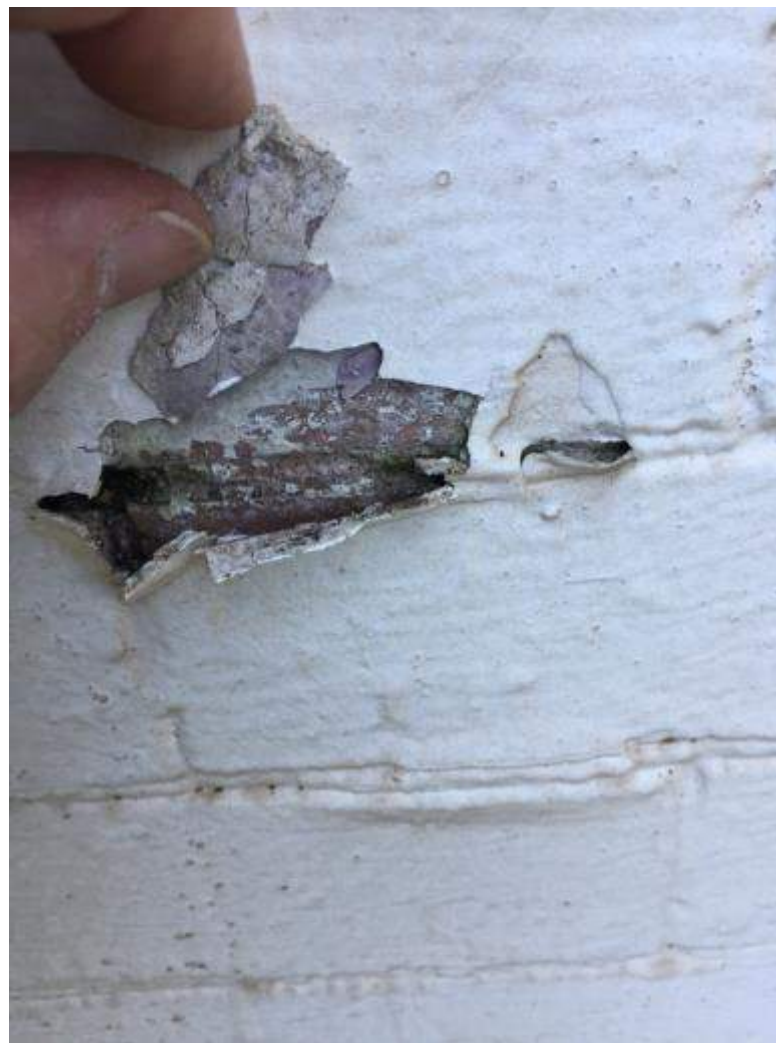
Photographs Numbered 49 and 50 show where a small breach in the coating results in moisture being trapped behind the coating and subsequently losing adhesion. We did not see where this was occurring on any locations other than where the previously installed coatings were left in place. That is due largely to the fact that the older coatings do not have the same moisture vapor transmission rate as the Newark coatings, and peels off.
