SUBJECT: Technical Memo - Annaburg Manor

Follow-up Site Observations

Manassas, Virginia

Report dated: July 13, 2017

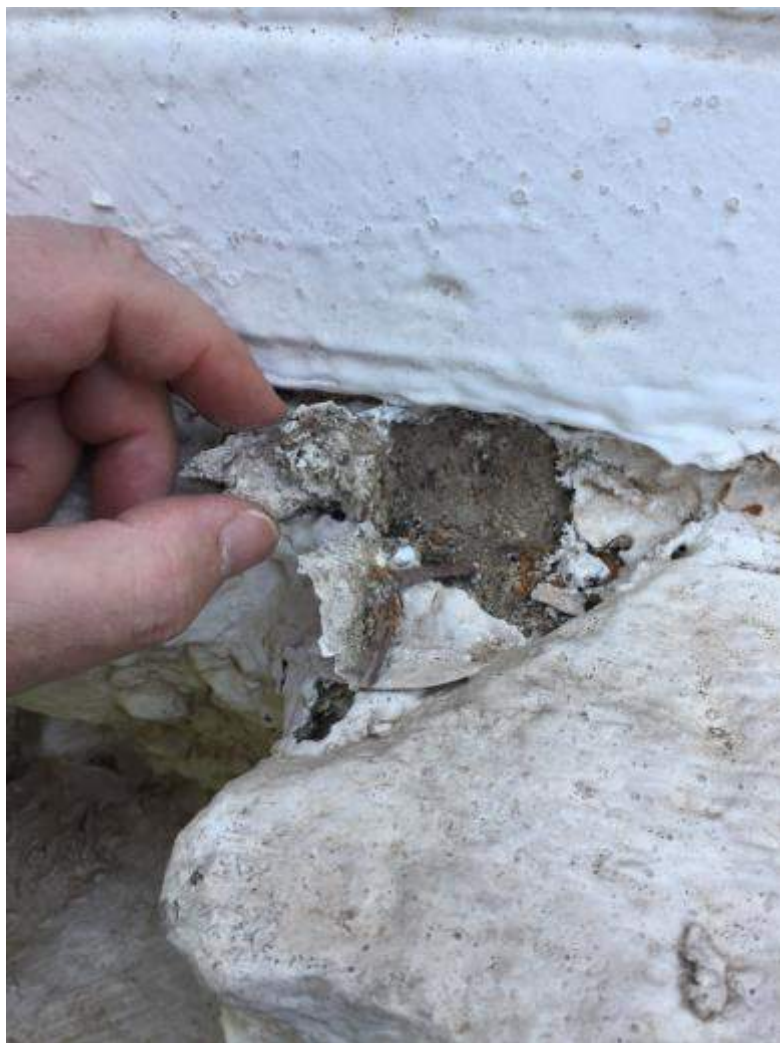
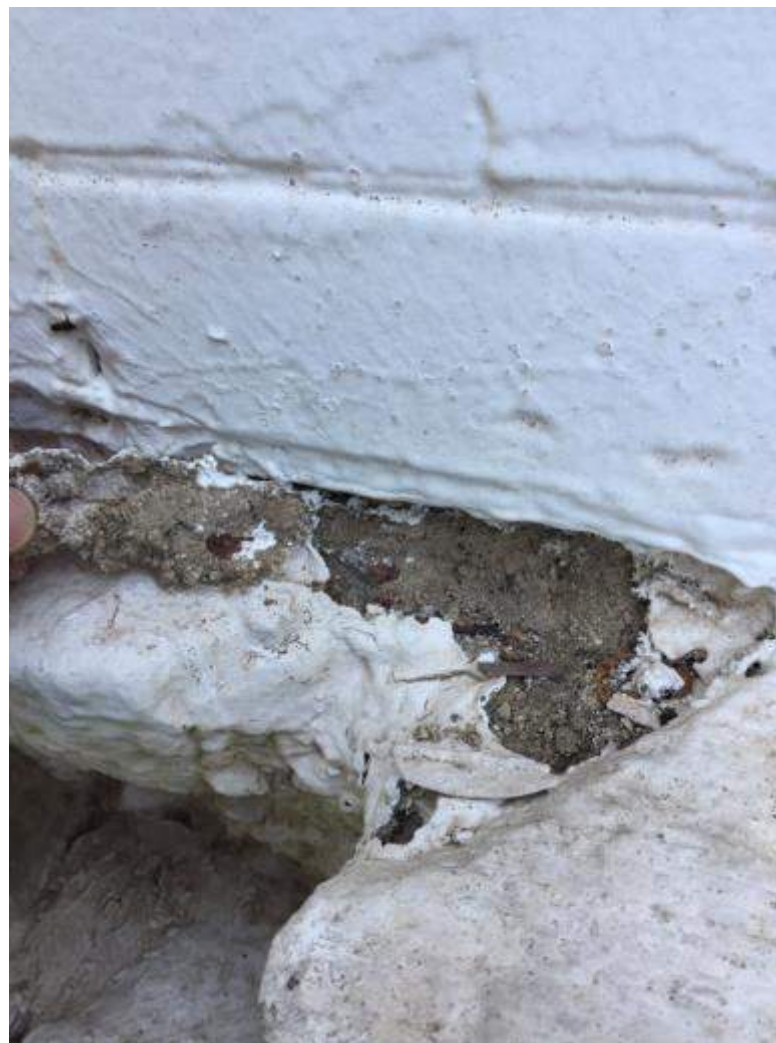
Photographs Numbered 53 and 54 identify where mortar is disintegrating behind where sealants have been installed, where again once this substrate becomes saturated causes the sealant and coating to lose adhesion.

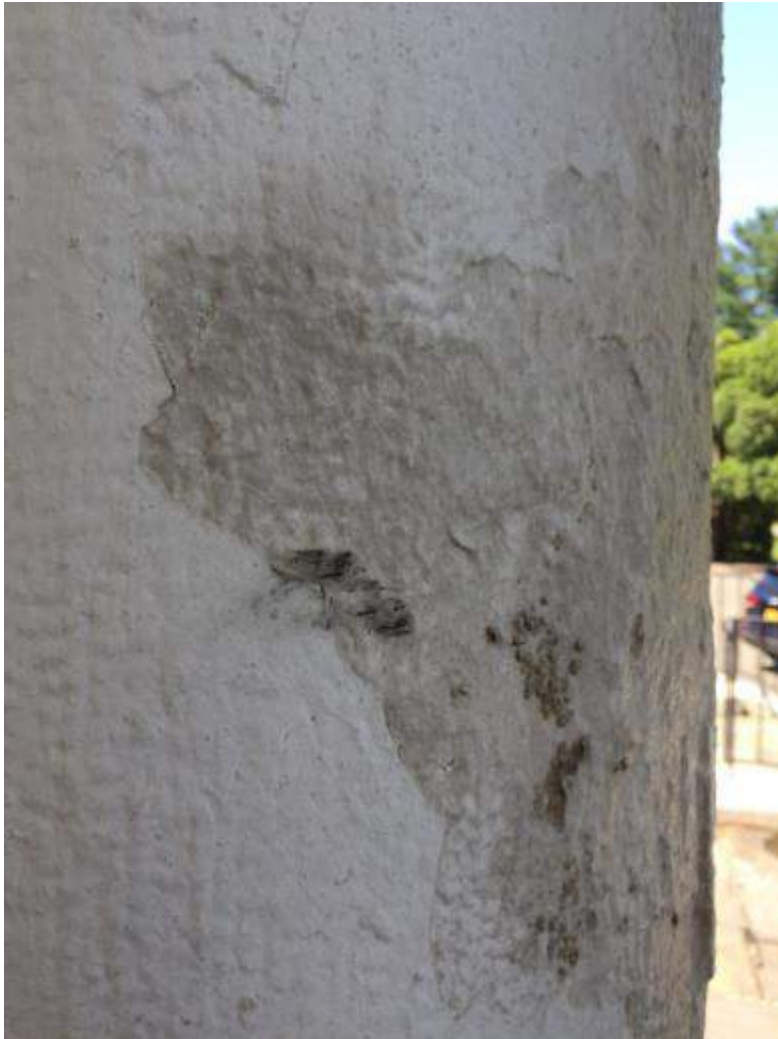
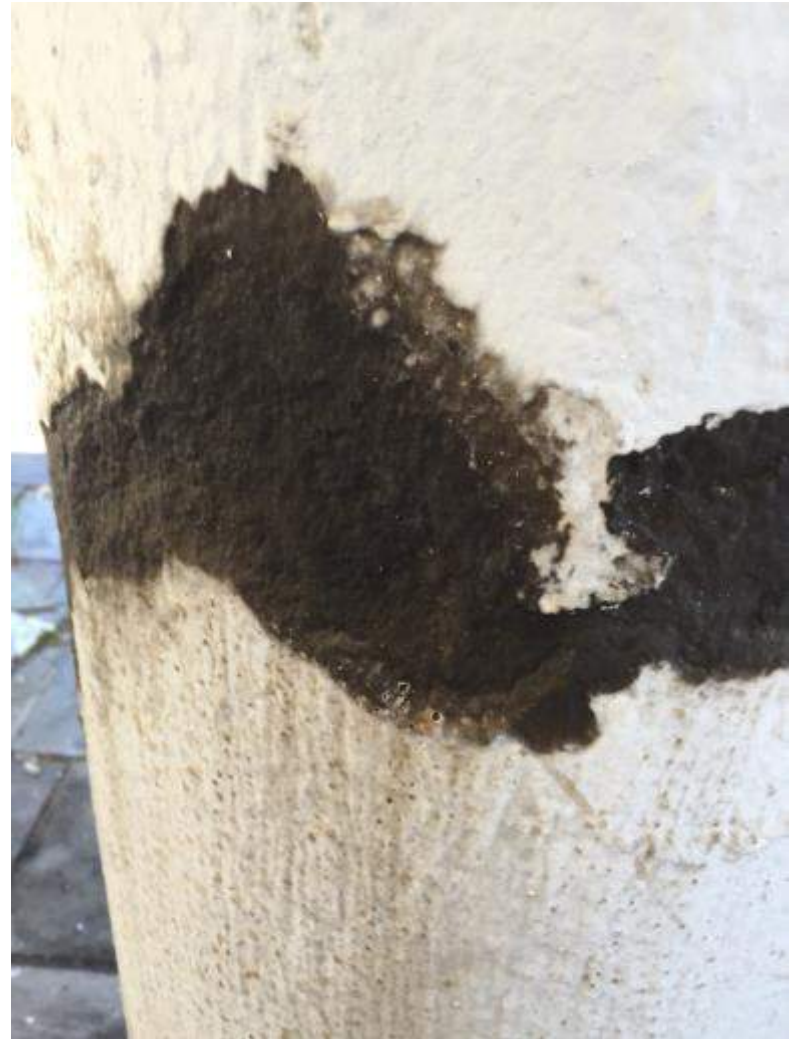
Photographs Numbered 55 and 56 shows deterioration of the coating, as well as further deterioration of the brownstone columns where water is getting into the columns.

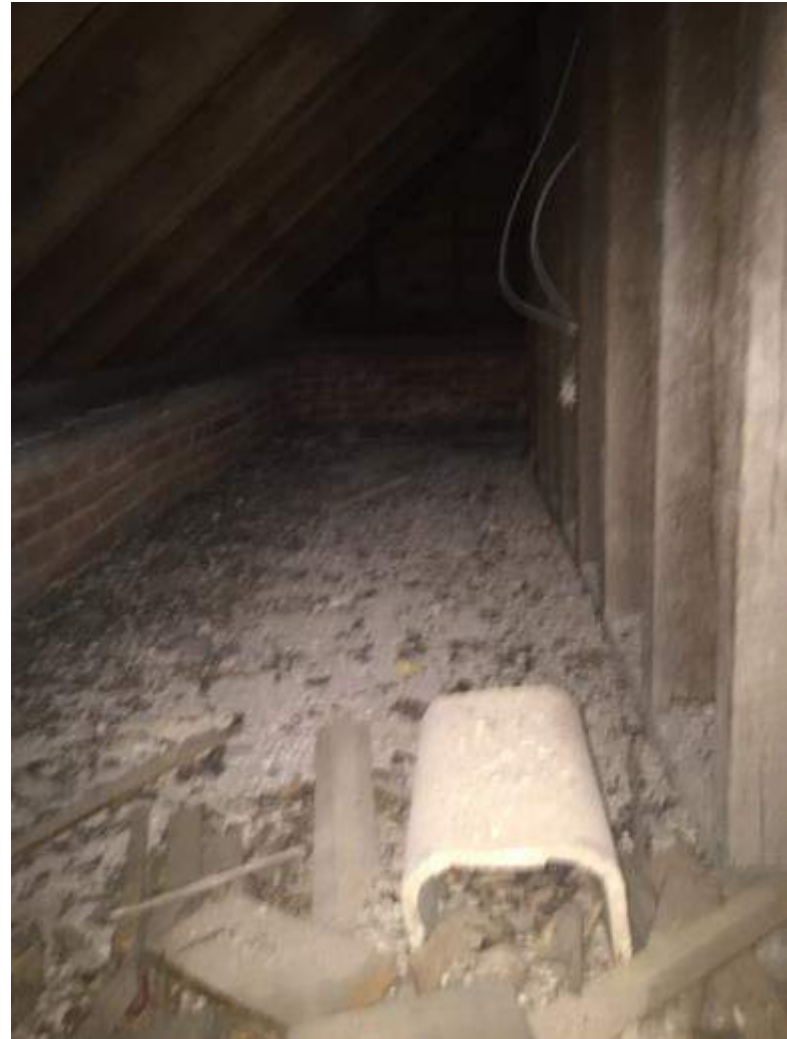
Photographs Numbered 57 through 59 show concealed areas on the interior that were known to have water leaks previously. In viewing these areas we did not find any of them with the apparent moisture, and believe the major leaking has still been stopped.

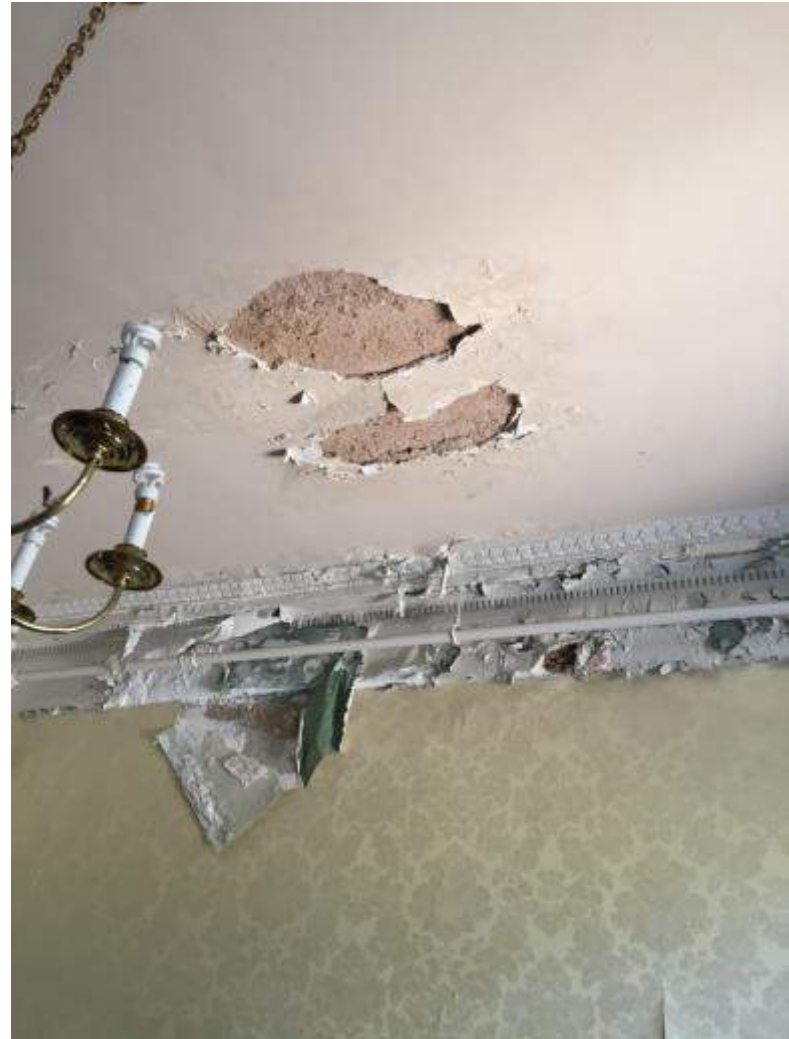
#60

Photograph number 60 shows one of the interior conditions that were compared to previous photographs on reports done earlier and do not appear to be significantly different.

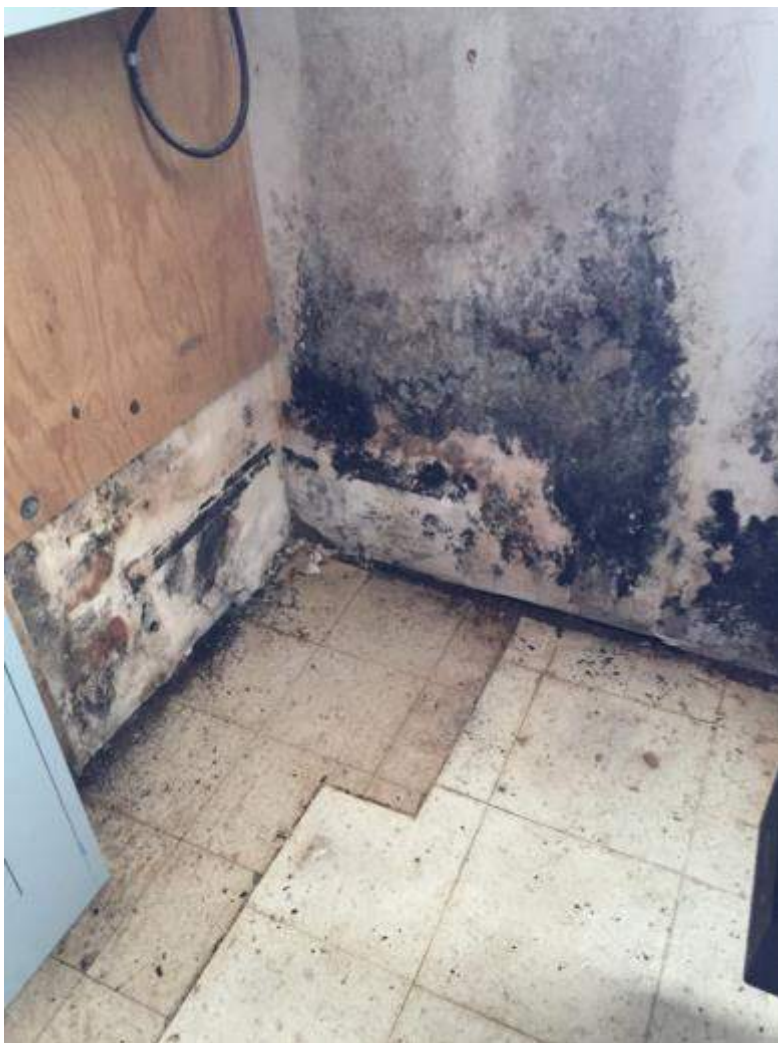
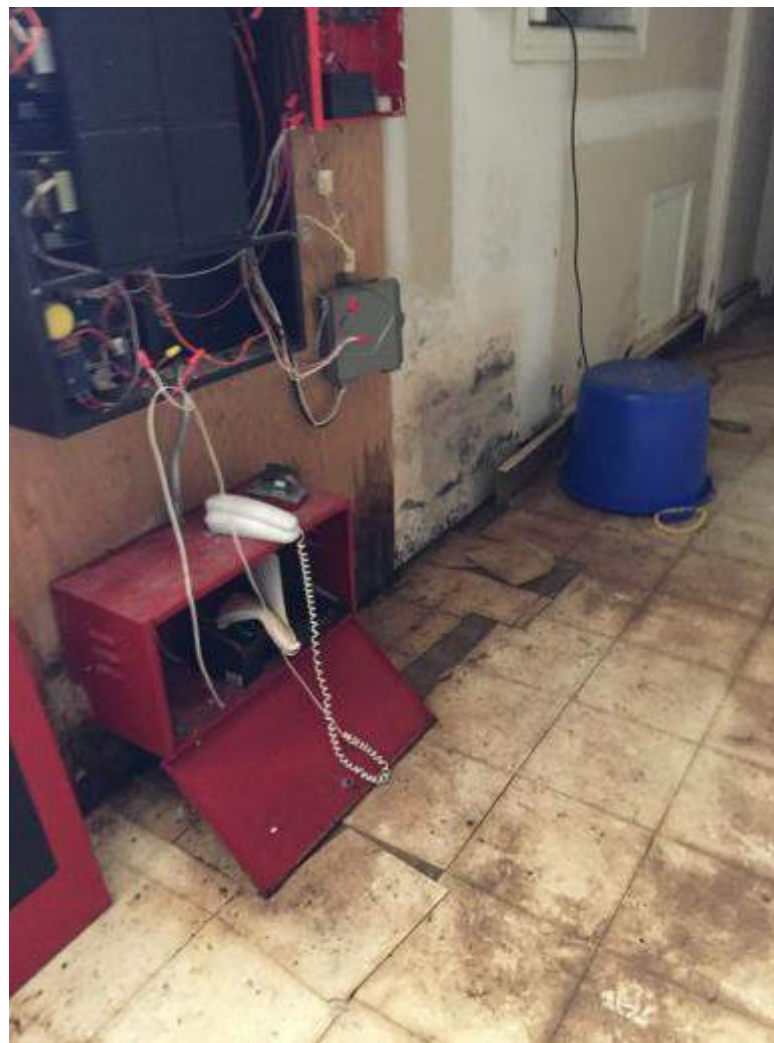
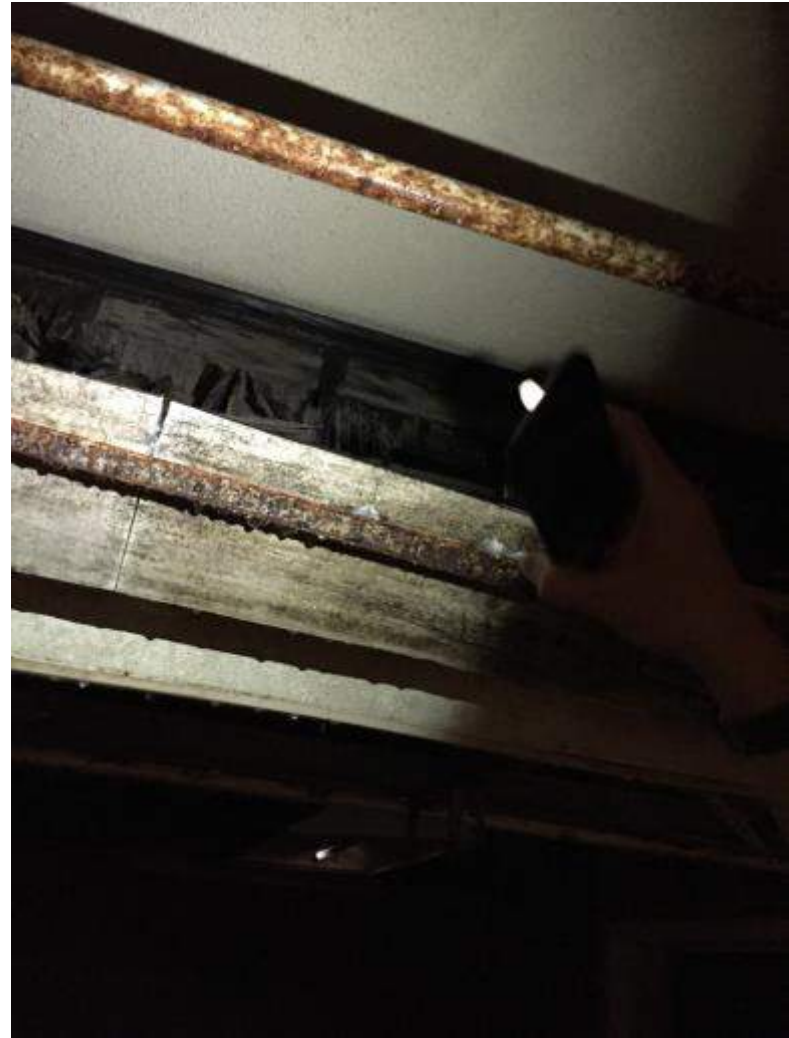
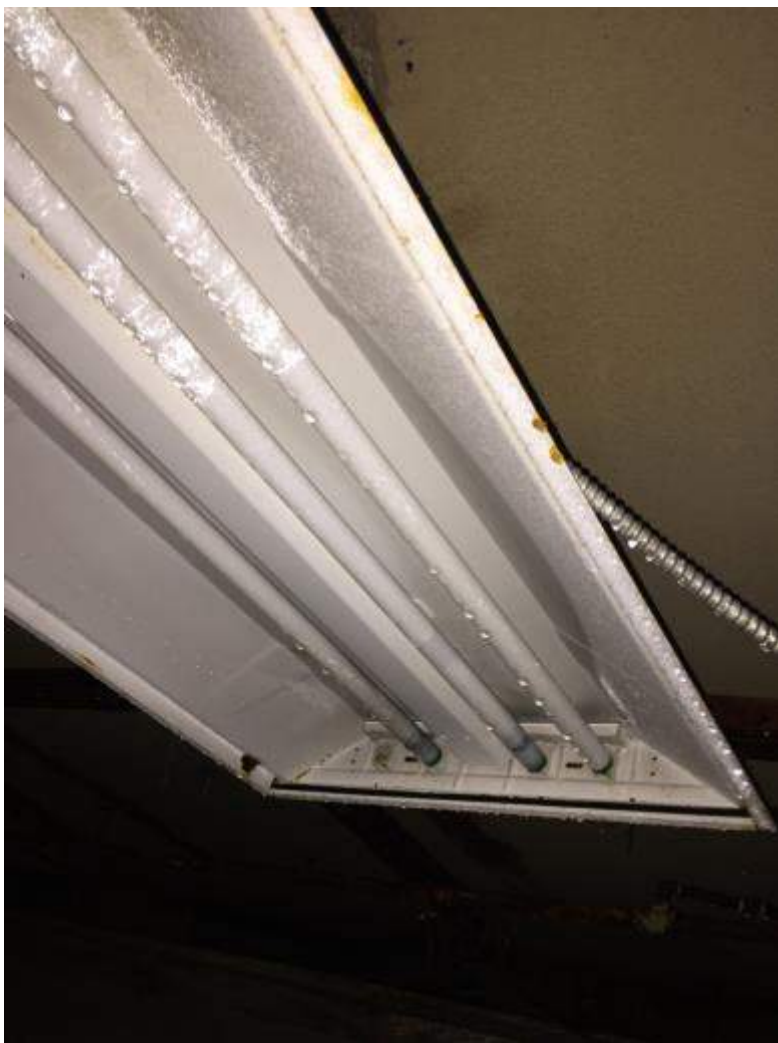
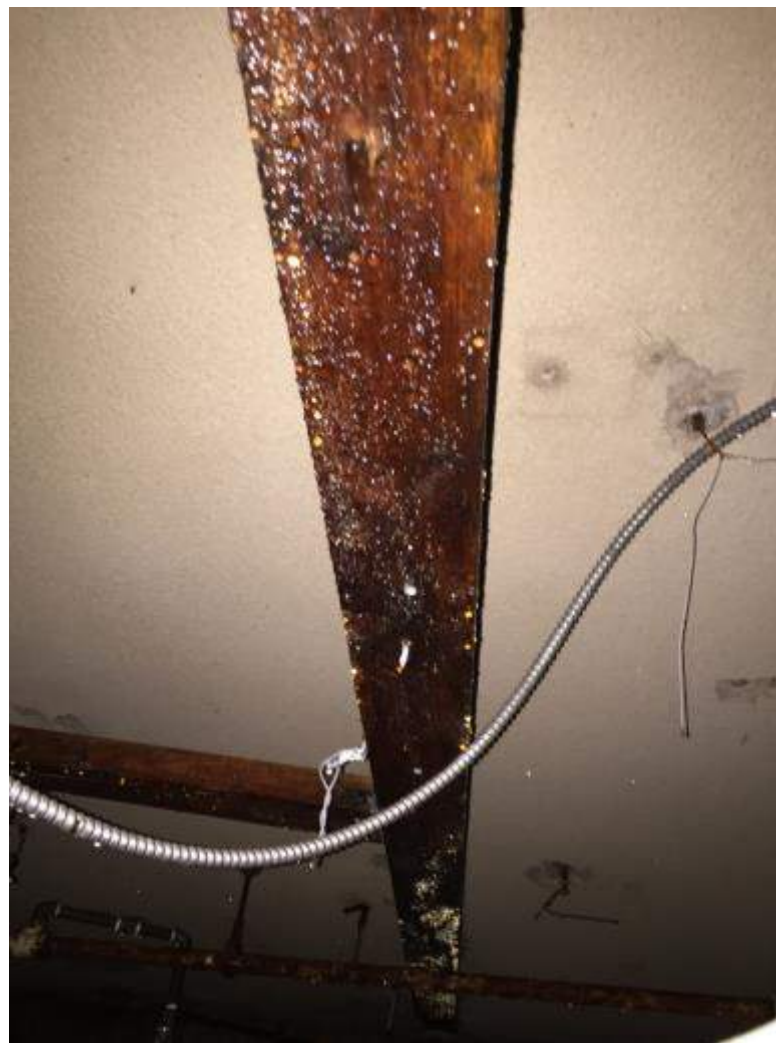
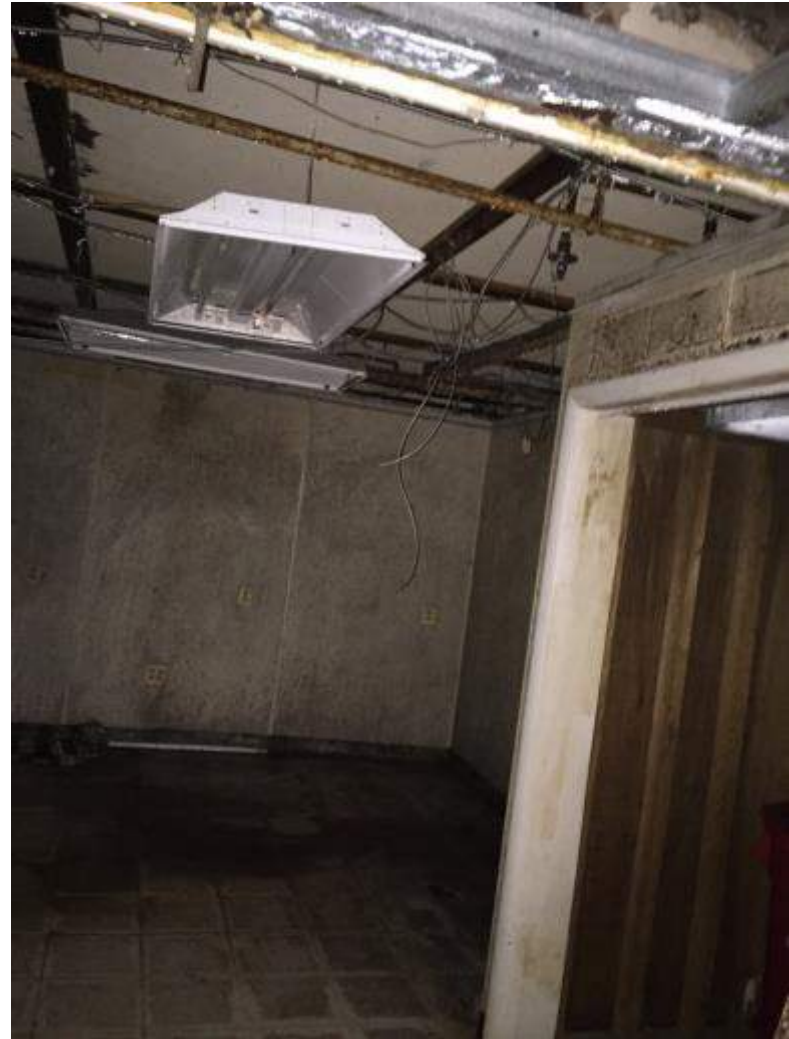
Photographs Numbered 61 through 74 show conditions on the sub grade portion of the building. There are extreme levels of moisture in this area as well as water that is running in around the perimeter of the basement. There is such a high level of humidity in this space that all of the overhead substrates and surfaces are dripping water. Water was dripping off of old light fixtures, steel beams, ceiling tile and other overhead surfaces. This is by far the worst condition that is affecting the building. Although no testing was done, we feel extremely confident that the mold present would not be conducive to having people in this area and would urge you to keep people out of here until such time as environmental test reports either confirm or refute this suspicion. The basement was one of the areas that was not addressed previously because of the significant cost associated with the remediation.

In reviewing previous budgets, which do not take into account damage that has occurred to the basement walls over the last couple of years, the hard costs exclusive of professional fees was in excess of \$300,000.00. We think this number would be higher today and any efforts going forward to attempt to salvage the building would need to be done after this has been accomplished, or it would not be wisely spent in our opinion. Once you have a direction on where you think they are going with this building long term, we could get some updated costs should you desire. We are preparing some order of magnitude budgets relative to bringing the portions of the building above grade back to where it was a couple of years ago and will send that under separate cover. Currently with the pricing that we have gotten back from firms who worked on this building previously, we are already at just over \$53,000.00 to correct the deficiencies from damage to the work that was completed a couple of years ago. This would need to have added to it, a budget for ongoing maintenance once this has been implemented, should they desire to have this done.

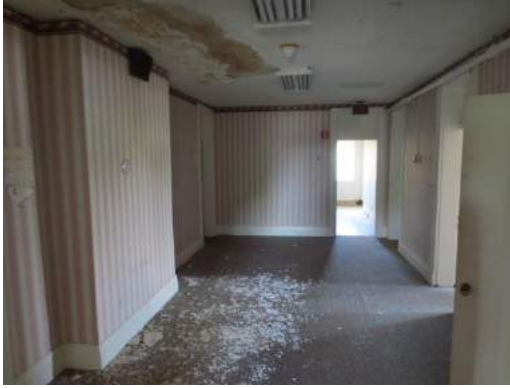
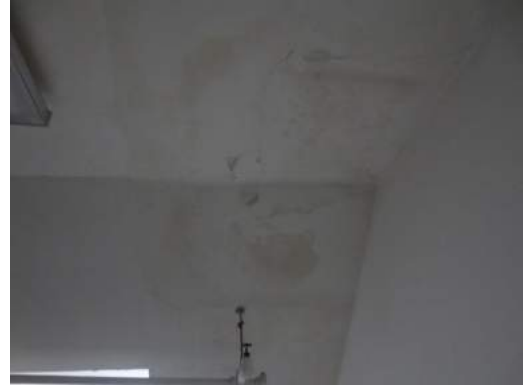
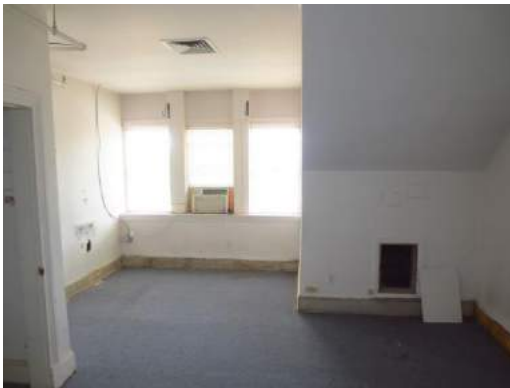
Third Floor

Evidence of water infiltration of the floors above the basement included observation of various areas of delaminating wall and ceiling plaster throughout the building primarily near the exterior walls. On the third floor, larger patches of ceiling plaster were delaminating and water stains were observed on carpeting indicating potential roof leaks. Water and mildew staining and was observed on the wood beams and ceiling of the attic. It is unclear if these conditions have worsened since the 2013 inspection.

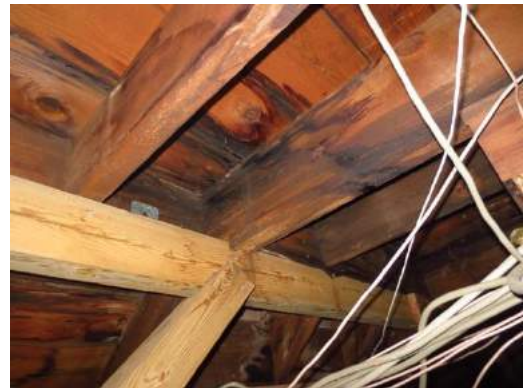
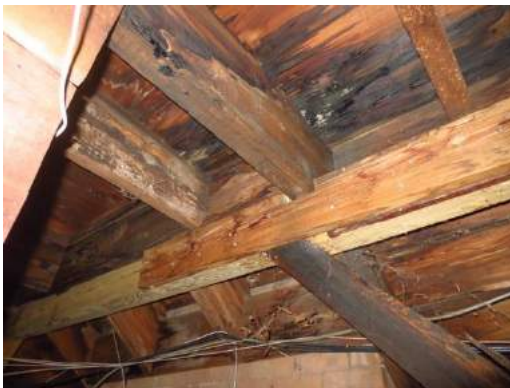
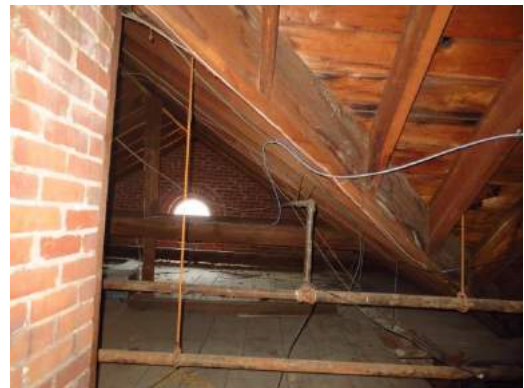
Attic roof wood sheathing and wood beams at the highest point adjacent to the brick chimney were identified wet through the use of the IR camera. The affected area is several square feet in area and visibly appears water stained and discolored.

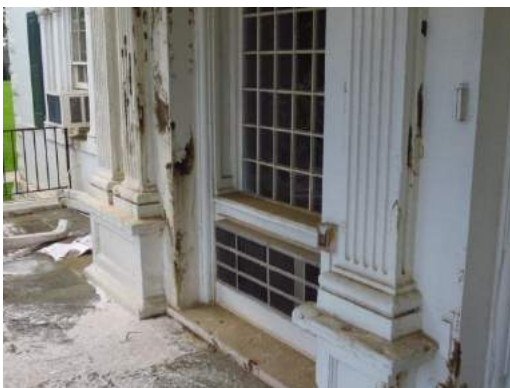
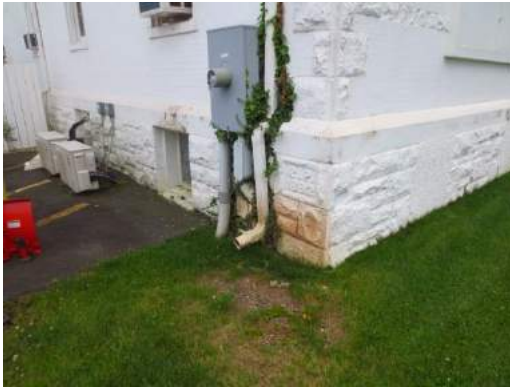
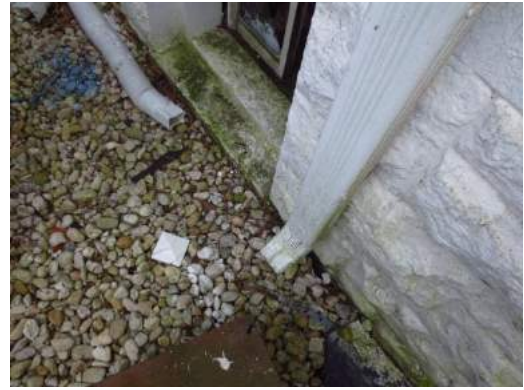
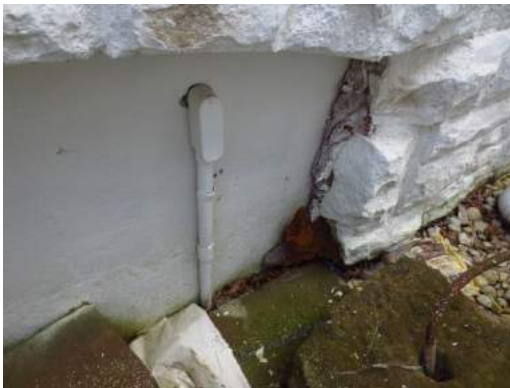
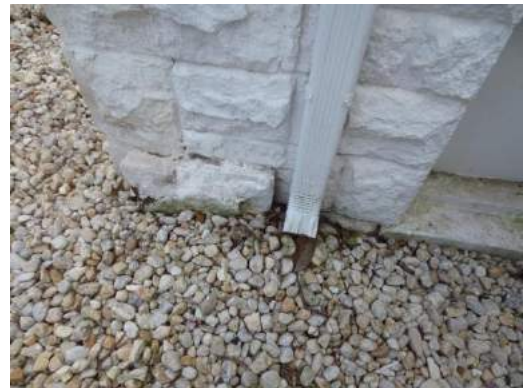
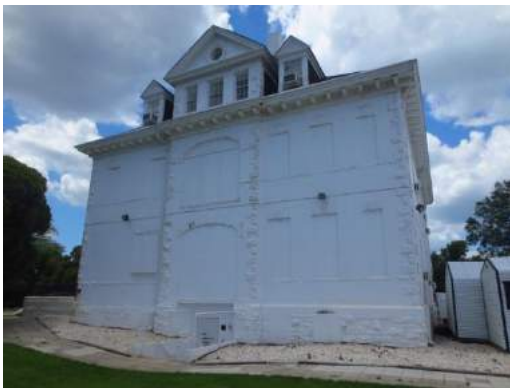
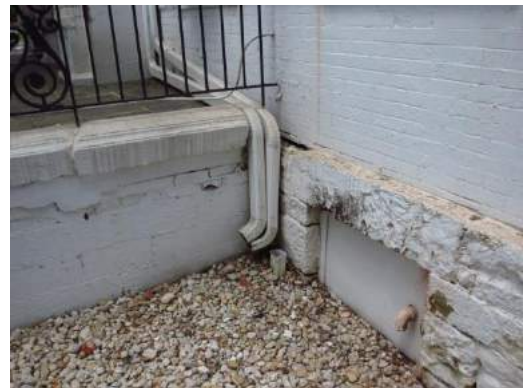
Exterior

All downspouts continue discharging directly adjacent to the building foundation contributing to basement water infiltration.

A window partially below grade in the southeast basement corner room and is still inadequately watertight.

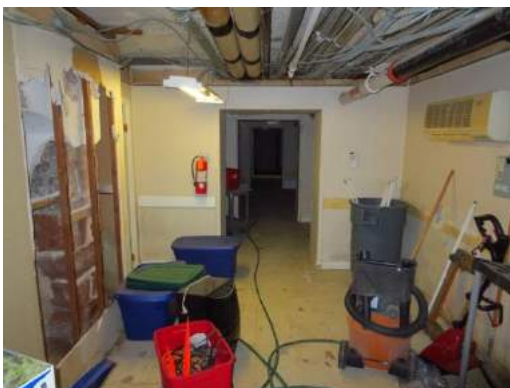
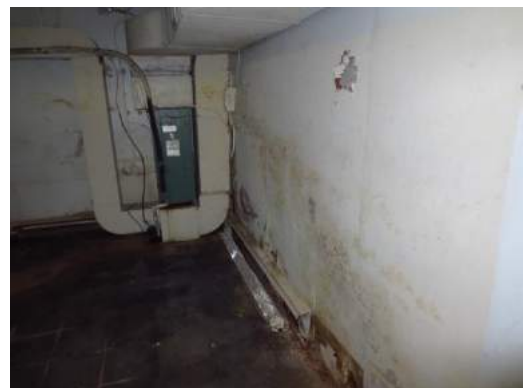
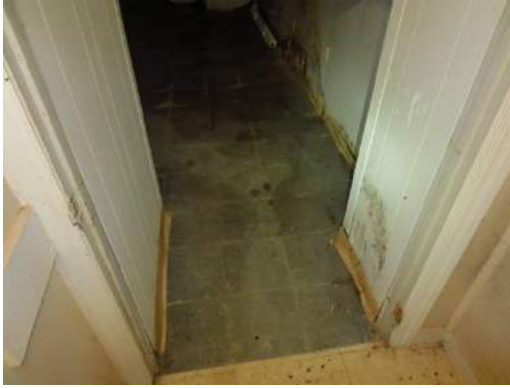
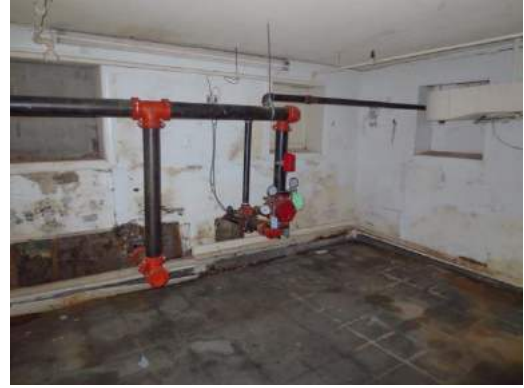
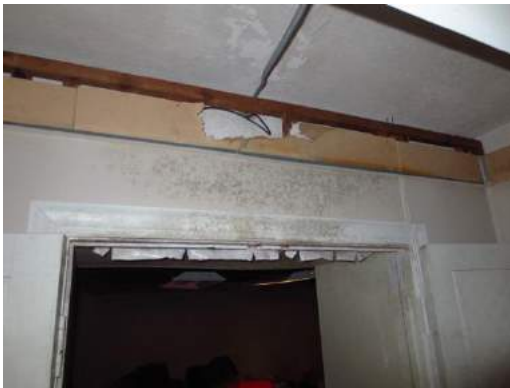
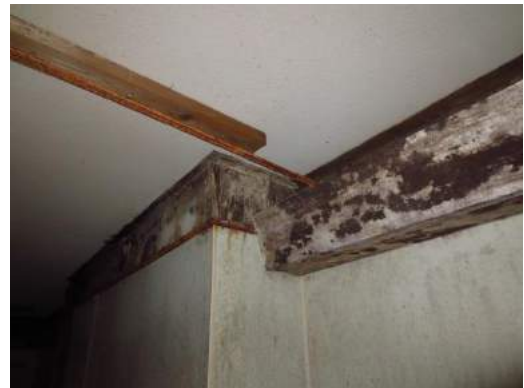
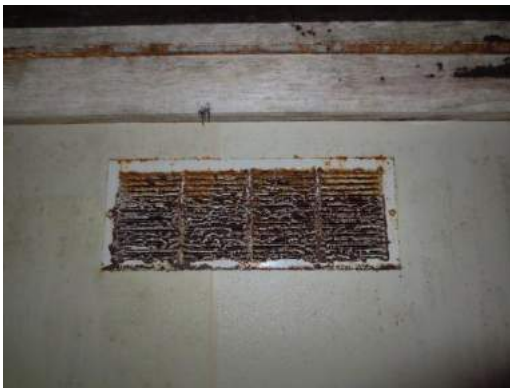
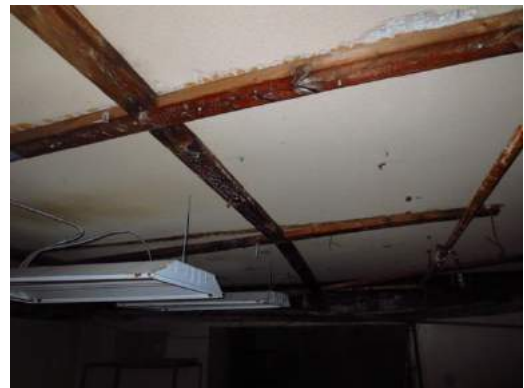
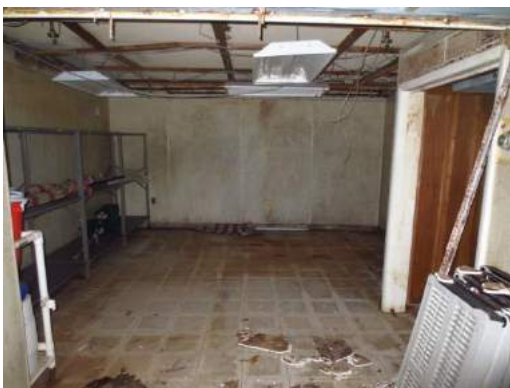
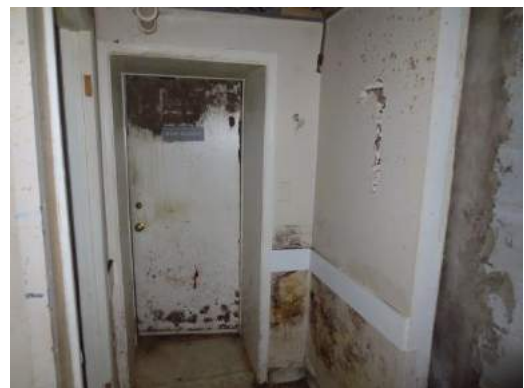
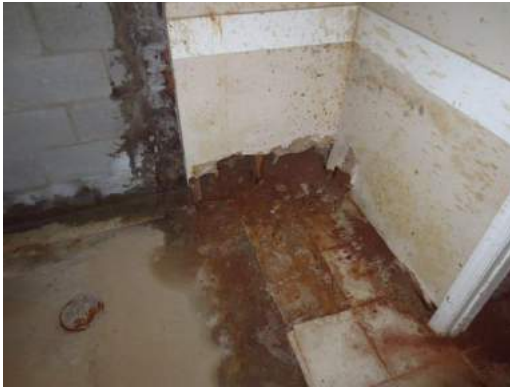
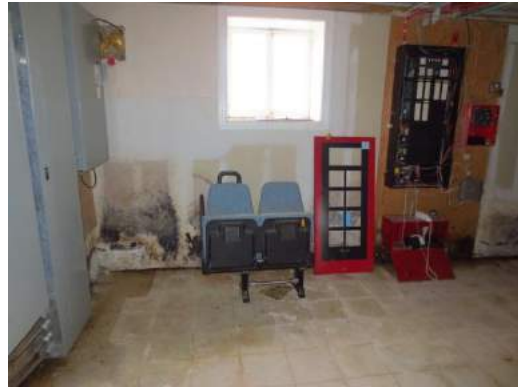
Basement walls and floors throughout the basement were identified wet through the use of the infrared camera and moisture meter. The walls are primarily sheetrock and the floors are vinyl tile on concrete. The sheetrock is wettest on the exterior walls at the floor (specifically at the areas that were blocked in during the 2007 demolition) and the moisture levels substantially diminish above the exterior ground level. The floors are wettest adjacent to the exterior walls. Identified wet areas appeared water stained, discolored, or visibly wet. These conditions have significantly worsened since the 2013 inspection. The amount of visible mold growth has also significantly increased within the basement.

Results of the mold air samples and surface wipe samples indicate the presence of persistently wet building materials within the building. Several areas of visible mold growth were observed on the lower basement walls. The *Stachybotrys* mold type was identified in three air samples and two wipe samples. *Stachybotrys* is an indicator of persistently wet conditions.
